Machine Id
KAESER 4969907

Component
Compressor

Fluid
KAESER SIGMA (OEM) M-460 (--- GAL)

OIL ANALYSIS REPORT

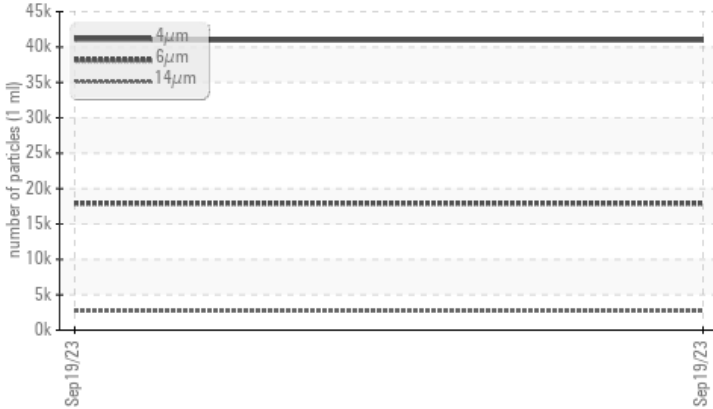
▲ Particle Trend

| Sample Status | | | ABNORMAL | --- | --- |
|---|---|---|---|---|---|
| Oil Cleanliness | ISO 4406 (c) | >--/17/13 | ▲ 23/21/19 | --- | --- |

Contamination
 There is a high amount of particulates present in the oil.

No corrective action is recommended at this time. The filter change at the time of sampling has been noted. Resample at the next service interval to monitor.
