# PROBLEM SUMMARY

Machine Id  
**090-0004 - BATCH FEEDER BELT**  
 Component  
**Gearbox**  
 Fluid  
**GEAR OIL ISO 220 (--- GAL)**

# OIL ANALYSIS REPORT

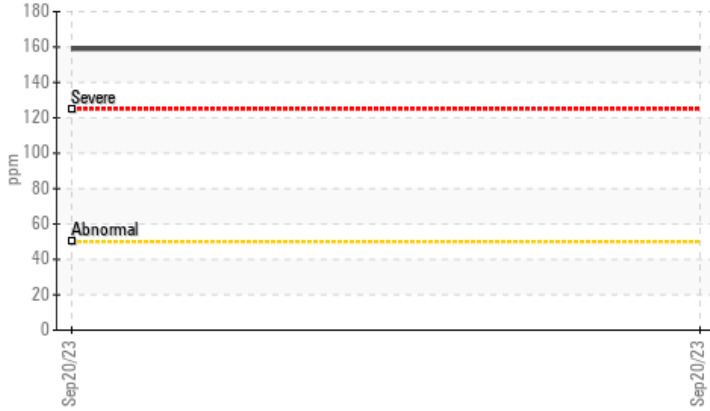
▲ Silicon (ppm)

Elemental level of silicon (Si) above normal indicating ingress of seal material.

method	limit/base	current	history1	history2	
Silicon	ppm	ASTM D5185m >50	<b>▲ 159</b>	---	---
Sodium	ppm	ASTM D5185m	<b>0</b>	---	---
Potassium	ppm	ASTM D5185m >20	<b>2</b>	---	---

No corrective action is recommended at this time. The oil change at the time of sampling has been noted. Resample at the next service interval to monitor.
