Machine Id
KAESER 5933439

Component
Compressor

Fluid
KAESER SIGMA (OEM) M-460 (--- GAL)

OIL ANALYSIS REPORT

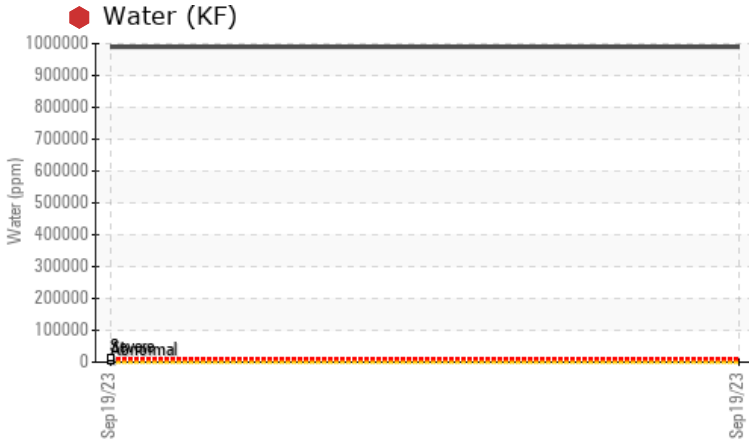
COMPONENT CONDITION SUMMARY

Appearance is milky. Sample consists almost entirely of free water. There is a high concentration of water present in the oil. Moderate concentration of visible dirt/debris present in the oil.

The oil is no longer serviceable due to the presence of contaminants.

The filter change at the time of sampling has been noted. We were unable to perform a particle count due to a high concentration of particles present in this sample. We advise that you stop the unit and follow the water drain-off procedure for this component. We recommend an early resample in 500 hours to monitor this condition.

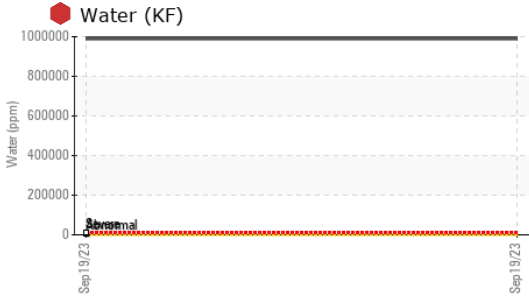
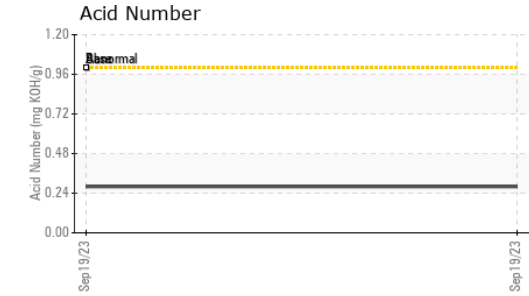
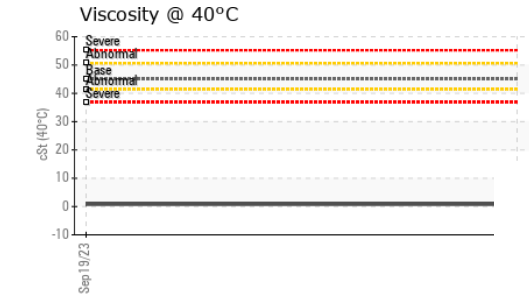
SAMPLE IMAGES	method	limit/base	current	history1	history2
---------------	--------	------------	---------	----------	----------

VISUAL	method	limit/base	current	history1	history2
White Metal	scalar	*Visual	NONE	NONE	---
Yellow Metal	scalar	*Visual	NONE	NONE	---
Precipitate	scalar	*Visual	NONE	NONE	---
Silt	scalar	*Visual	NONE	NONE	---
Debris	scalar	*Visual	NONE	▲ MODER	---
Sand/Dirt	scalar	*Visual	NONE	NONE	---
Appearance	scalar	*Visual	NORML	▲ MILKY	---
Odor	scalar	*Visual	NORML	NORML	---
Emulsified Water	scalar	*Visual	>0.05	● 0.2%	---
Free Water	scalar	*Visual		▲ >10%	---
