OIL ANALYSIS REPORT

Machine Id
JENBACHER GM01 (S/N 1144754)
 Component
Biogas Engine
 Fluid
MAHLER Q8 Mahler G8 SAE 40 (--- GAL)

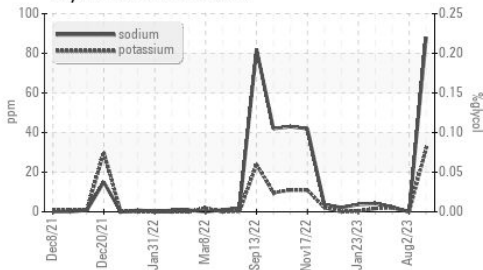
Glycol Contamination

Sodium and/or potassium levels are high. Test for glycol is negative.

No corrective action is recommended at this time. We recommend an early resample to monitor this condition.

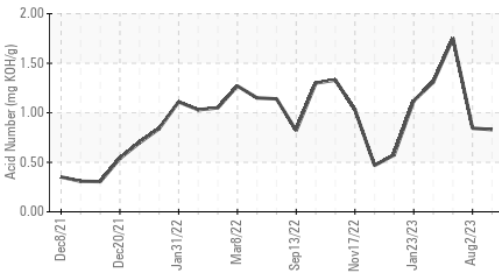
Acid Number

The BN result indicates that there is suitable alkalinity remaining in the oil. The AN level is acceptable for this fluid. The condition of the oil is suitable for further service.

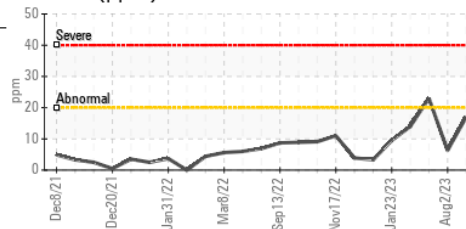
Iron (ppm)

All component wear rates are normal.
