OIL ANALYSIS REPORT

Machine Id
GT-1 (S/N 22115)

Component
Gearbox

Fluid
ROYAL PURPLE SYNERGY 140/460 (--- GAL)

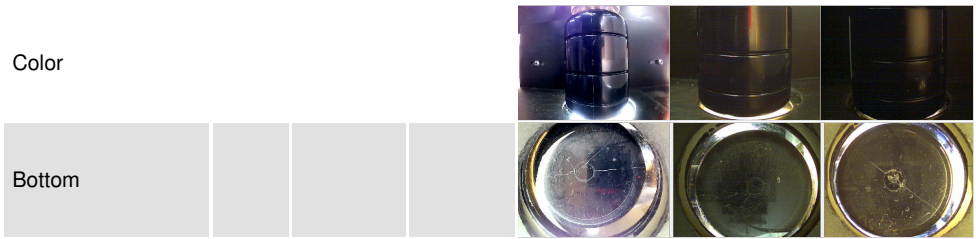
SAMPLE IMAGES	method	limit/base	current	history1	history2
---------------	--------	------------	---------	----------	----------

VISUAL	method	limit/base	current	history1	history2
White Metal	scalar	*Visual	NONE	MODER	NONE
Yellow Metal	scalar	*Visual	NONE	NONE	MODER
Precipitate	scalar	*Visual	NONE	NONE	NONE
Silt	scalar	*Visual	NONE	NONE	NONE
Debris	scalar	*Visual	NONE	NONE	LIGHT
Sand/Dirt	scalar	*Visual	NONE	NONE	NONE
Appearance	scalar	*Visual	NORML	NORML	NORML
Odor	scalar	*Visual	NORML	NORML	NORML
Emulsified Water	scalar	*Visual	>0.2	NEG	NEG
Free Water	scalar	*Visual		NEG	NEG

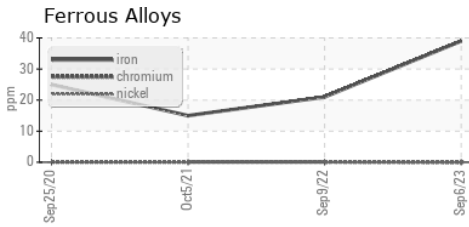
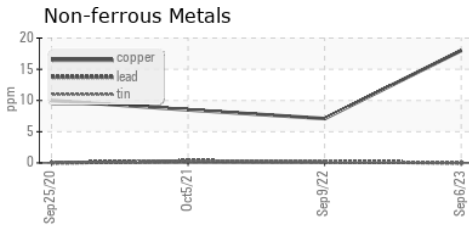
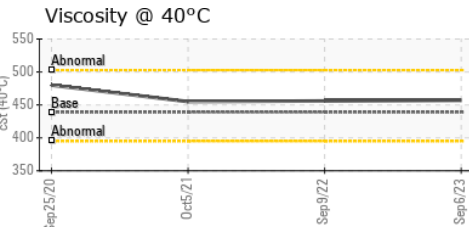
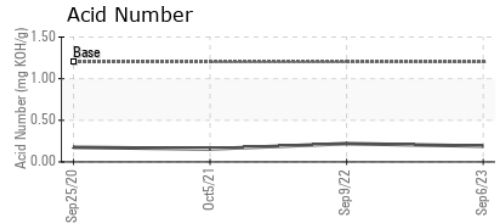
GRAPHS

All component wear rates are normal.

There is no indication of any contamination in the oil.

The AN level is acceptable for this fluid. The condition of the oil is suitable for further service.

Resample at the next service interval to monitor.
