OIL ANALYSIS REPORT

Machine Id
PTU-2 - M2-0313

Component
Gearbox

Fluid
ROYAL PURPLE SYNERGY 140/460 (--- GAL)

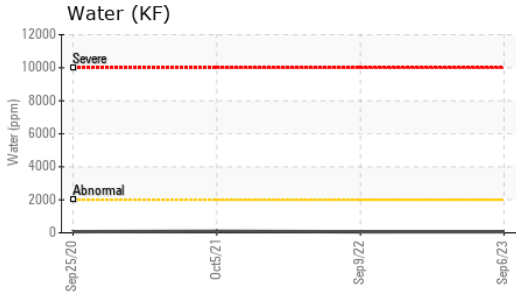
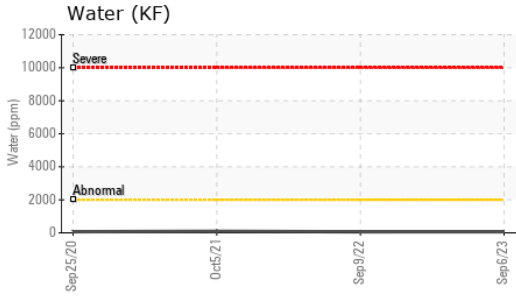
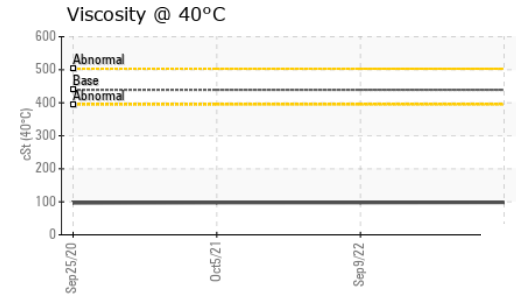
All component wear rates are normal.

There is no indication of any contamination in the oil.

Confirm oil type. The AN level is acceptable for this fluid. The condition of the oil is suitable for further service.

Resample at the next service interval to monitor.

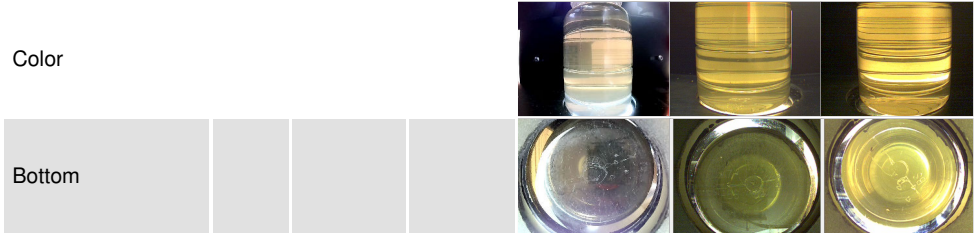
SAMPLE IMAGES	method	limit/base	current	history1	history2
---------------	--------	------------	---------	----------	----------

VISUAL	method	limit/base	current	history1	history2
White Metal	scalar	*Visual	NONE	NONE	NONE
Yellow Metal	scalar	*Visual	NONE	NONE	NONE
Precipitate	scalar	*Visual	NONE	NONE	NONE
Silt	scalar	*Visual	NONE	NONE	NONE
Debris	scalar	*Visual	NONE	NONE	NONE
Sand/Dirt	scalar	*Visual	NONE	NONE	NONE
Appearance	scalar	*Visual	NORML	NORML	NORML
Odor	scalar	*Visual	NORML	NORML	NORML
Emulsified Water	scalar	*Visual	>0.2	NEG	NEG
Free Water	scalar	*Visual		NEG	NEG
