FUEL REPORT

Area
[PMIAS2811277]
 Machine Id
CUMMINS 18856508 97-20C318-1 - 300CA
 Component
Diesel Fuel
 Fluid
NOT GIVEN (--- GAL)

Laboratory : WearCheck USA - 501 Madison Ave., Cary, NC 27513
Sample No. : DC0029089 **Received** : 28 Sep 2023
Lab Number : **05964360** **Diagnosed** : 09 Oct 2023
Unique Number : 10670911 **Diagnostician** : Doug Bogart
Test Package : DF-5 (Additional Tests: API, Cetane, Fuel, Screen)

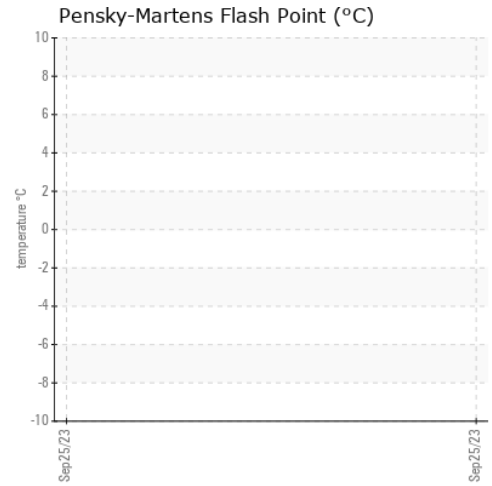
GRAPHS

All laboratory tests indicate that this sample meets specifications for No.2 low-sulfur diesel fuel.

All metal levels are normal indicating no corrosion in the system.

The water content is negligible. There is no bacteria or fungus (yeast and/or mold) indicated in the sample. There is no indication of any contamination in the fuel.
