OIL ANALYSIS REPORT

Machine Id
KAESER 6136146 - SCHDEL (S/N 1365)

Component
Compressor
Fluid
KAESER SIGMA (OEM) S-460 (10 GAL)

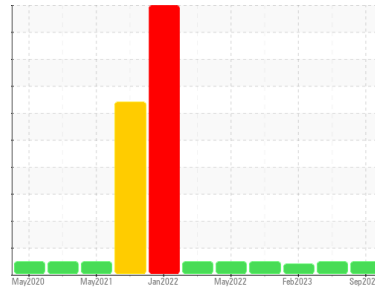
Sample Rating Trend

NORMAL

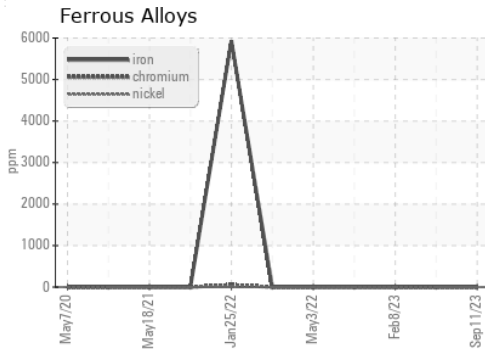
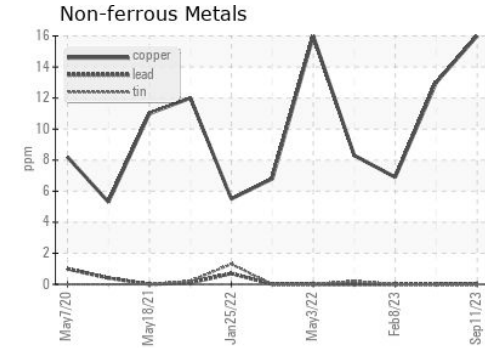
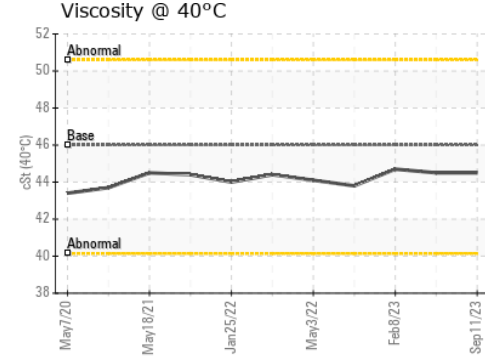
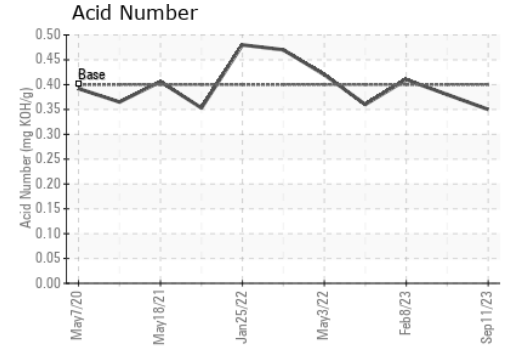
GRAPHS

All component wear rates are normal.

There is no indication of any contamination in the oil.

The AN level is acceptable for this fluid. The condition of the oil is suitable for further service.

Resample at the next service interval to monitor.
