Machine Id
302 E EXT
 Component
Gearbox
 Fluid
NOT GIVEN (--- GAL)

Customer Id: PLAADR
 Sample No.: PH0001269
 Lab Number: 05965368
 Test Package: PLANT

OIL ANALYSIS REPORT

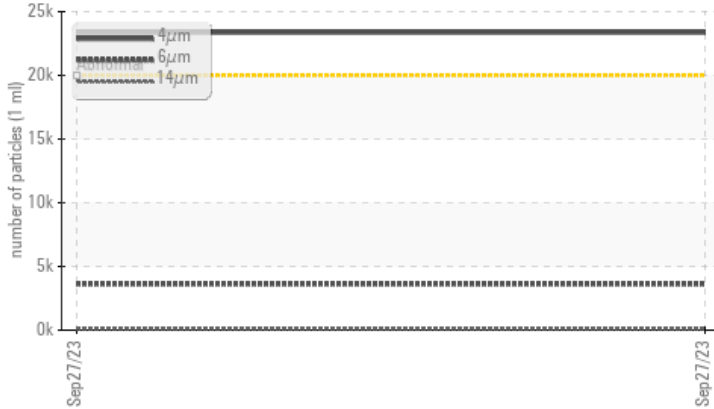
▲ Particle Trend

Sample Status				ATTENTION	---	---
Particles >4µm	ASTM D7647	>20000	▲ 23365	---	---	---
Oil Cleanliness	ISO 4406 (c)	>21/19/16	▲ 22/19/14	---	---	---
PrtFilter					no image	no image

There is a moderate amount of silt (particulates < 6 microns in size) present in the oil.

No corrective action is recommended at this time.
 Resample at the next service interval to monitor.
 Please specify the brand, type, and viscosity of the oil on your next sample.
