OIL ANALYSIS REPORT

CHEATHAM ANNEX 1AHW CRANE 1A

Component Gearbox

SHELL OMALA S4 WE 220 (--- GAL)

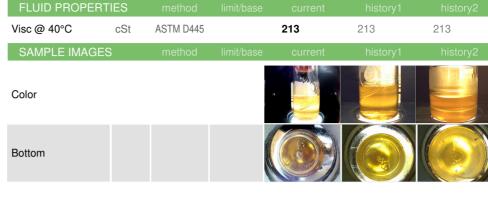
GRAPHS Ferrous Alloys

All component wear rates are normal.

There is no indication of any contamination in the

The AN level is acceptable for this fluid. The condition of the oil is suitable for further service.

Resample at the next service interval to monitor.
