# PROBLEM SUMMARY

Machine Id  
**CG8260**  
 Component  
**Upper Hydraulic System**  
 Fluid  
**AW HYDRAULIC OIL ISO 46 (--- GAL)**

# OIL ANALYSIS REPORT

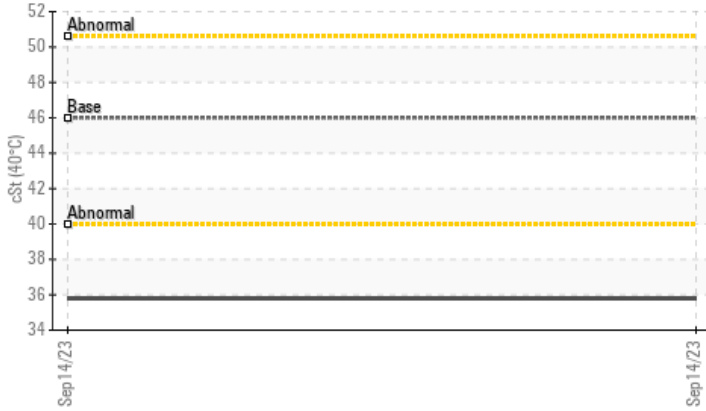
▲ Viscosity @ 40°C

Sample Status				ATTENTION	---	---
Visc @ 40°C	cSt	ASTM D445	46	▲ 35.8	---	---

The oil viscosity is lower than normal. The AN level is acceptable for this fluid.

Oil and filter change at the time of sampling has been noted. Resample at the next service interval to monitor.
