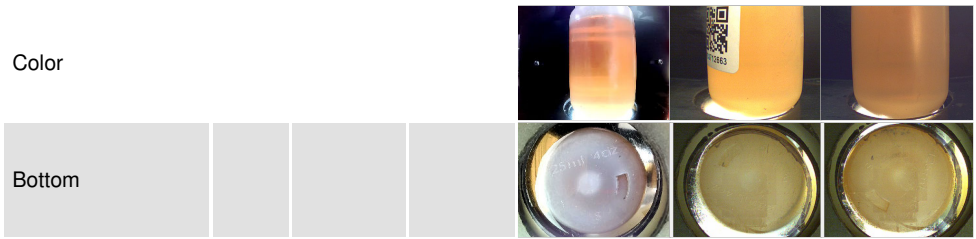
SAMPLE IMAGES	method	limit/base	current	history1	history2
---------------	--------	------------	---------	----------	----------

VISUAL	method	limit/base	current	history1	history2
White Metal	scalar	*Visual	NONE	NONE	NONE
Yellow Metal	scalar	*Visual	NONE	NONE	NONE
Precipitate	scalar	*Visual	NONE	NONE	NONE
Silt	scalar	*Visual	NONE	NONE	NONE
Debris	scalar	*Visual	NONE	NONE	NONE
Sand/Dirt	scalar	*Visual	NONE	NONE	NONE
Appearance	scalar	*Visual	NORML	NORML	NORML
Odor	scalar	*Visual	NORML	NORML	NORML
Emulsified Water	scalar	*Visual	>0.1	NEG	NEG
Free Water	scalar	*Visual		NEG	NEG

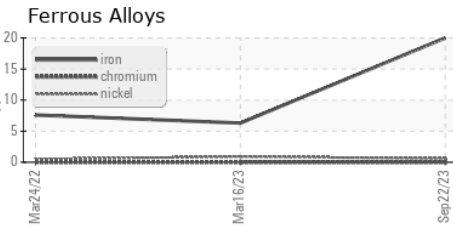
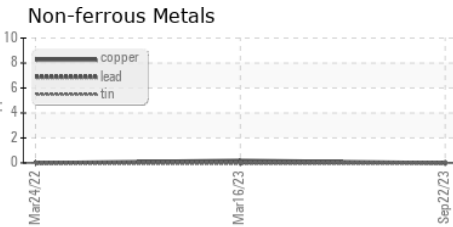
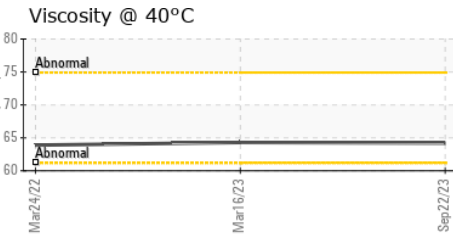
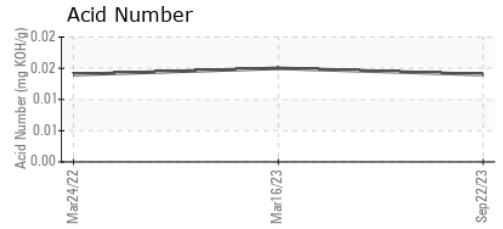
GRAPHS

All component wear rates are normal.

There is no indication of any contamination in the oil.

The AN level is acceptable for this fluid. The condition of the oil is suitable for further service.

Resample at the next service interval to monitor.
