OIL ANALYSIS REPORT

Area
RIVERMAID [FAJ8671]
 Machine Id
GEA SC03 (S/N N1336)
 Component
Screw Compressor
 Fluid
SUMMIT RHT-68 (40 GAL)

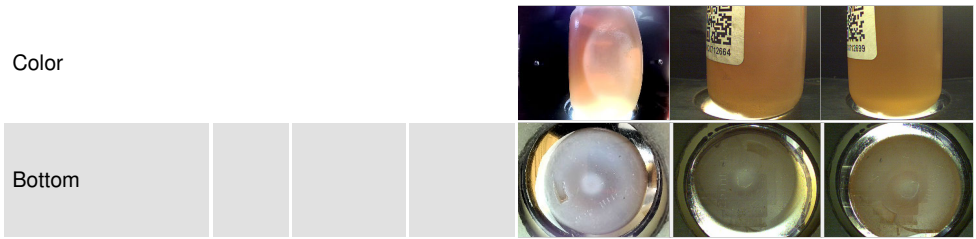
SAMPLE IMAGES	method	limit/base	current	history1	history2
---------------	--------	------------	---------	----------	----------

VISUAL	method	limit/base	current	history1	history2
White Metal	scalar	*Visual	NONE	NONE	NONE
Yellow Metal	scalar	*Visual	NONE	NONE	NONE
Precipitate	scalar	*Visual	NONE	NONE	NONE
Silt	scalar	*Visual	NONE	NONE	NONE
Debris	scalar	*Visual	NONE	LIGHT	NONE
Sand/Dirt	scalar	*Visual	NONE	NONE	NONE
Appearance	scalar	*Visual	NORML	NORML	NORML
Odor	scalar	*Visual	NORML	NORML	NORML
Emulsified Water	scalar	*Visual	>0.1	NEG	NEG
Free Water	scalar	*Visual		NEG	NEG

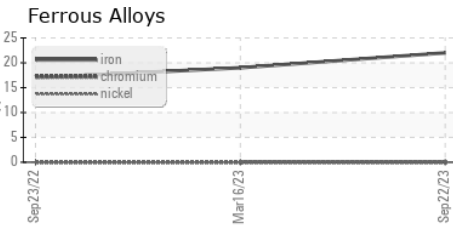
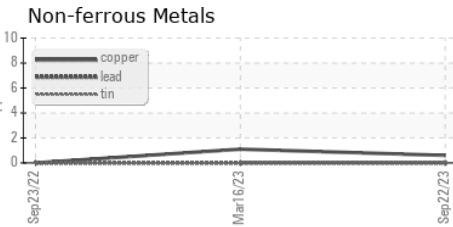
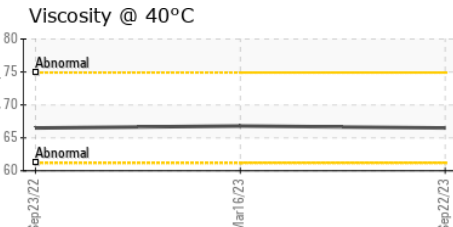
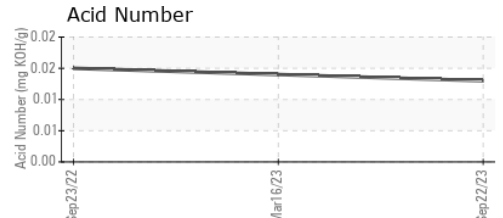
GRAPHS

All component wear rates are normal.

There is no indication of any contamination in the oil.

The AN level is acceptable for this fluid. The condition of the oil is suitable for further service.

Resample at the next service interval to monitor.
