Machine Id  
**KAESER SM 10 4549499 (S/N 1089)**

Component  
**Compressor**

Fluid  
**KAESER SIGMA (OEM) S-460 (--- GAL)**

# OIL ANALYSIS REPORT

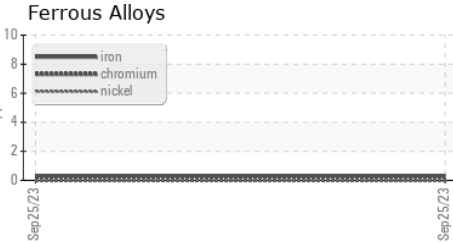
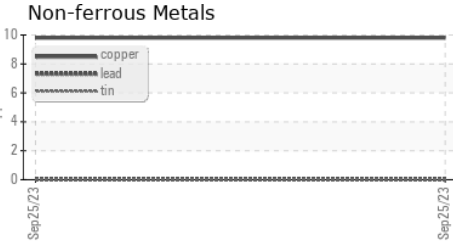
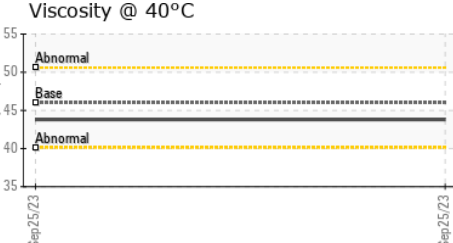
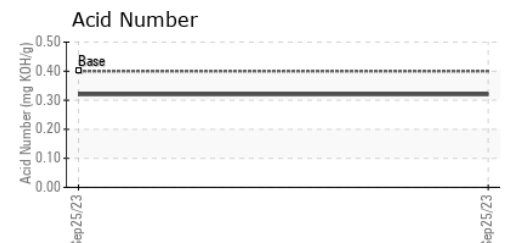
## GRAPHS

method	limit/base	current	history1	history2
Silicon	ppm	ASTM D5185m >25	<b>&lt;1</b>	---	---
Sodium	ppm	ASTM D5185m	<b>10</b>	---	---
Potassium	ppm	ASTM D5185m >20	<b>2</b>	---	---
Water	%	ASTM D6304 >0.05	<b>▲ 0.173</b>	---	---
ppm Water	ppm	ASTM D6304 >500	<b>▲ 1730</b>	---	---

method	limit/base	current	history1	history2
Acid Number (AN)	mg KOH/g	ASTM D8045 0.4	<b>0.32</b>	---	---
