Machine Id
COX 9402743
 Component
Boom Winch
 Fluid
GEAR OIL ISO 220 (--- GAL)

Customer Id: SEALAF
 Sample No.: WC0825738
 Lab Number: 05967912
 Test Package: IND 2

OIL ANALYSIS REPORT

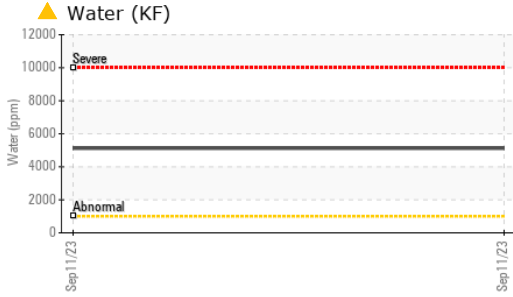
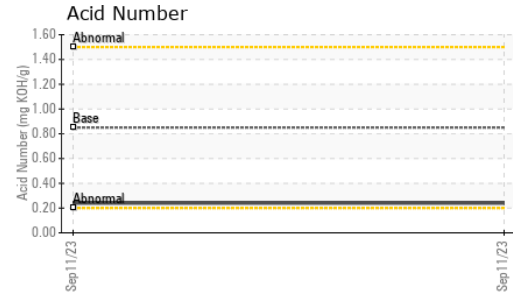
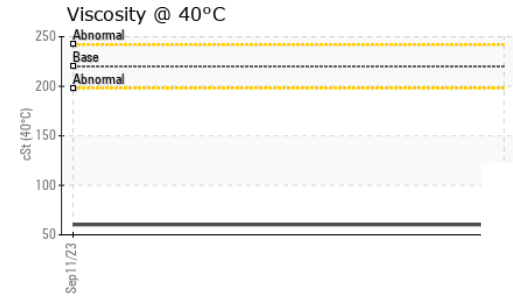
VISUAL	method	limit/base	current	history1	history2
White Metal	scalar	*Visual	NONE	NONE	---
Yellow Metal	scalar	*Visual	NONE	NONE	---
Precipitate	scalar	*Visual	NONE	NONE	---
Silt	scalar	*Visual	NONE	NONE	---
Debris	scalar	*Visual	NONE	LIGHT	---
Sand/Dirt	scalar	*Visual	NONE	NONE	---
Appearance	scalar	*Visual	NORML	▲ HAZY	---
Odor	scalar	*Visual	NORML	NORML	---
Emulsified Water	scalar	*Visual	>0.1	0.2%	---
Free Water	scalar	*Visual		▲ 1.0	---
