OIL ANALYSIS REPORT

Machine Id
C0160 - SOUTH BRIDGE

Component
Gearbox
Fluid
NOT GIVEN (--- GAL)

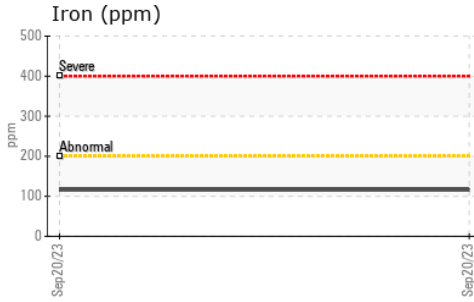
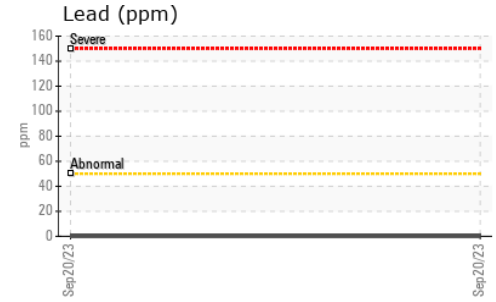
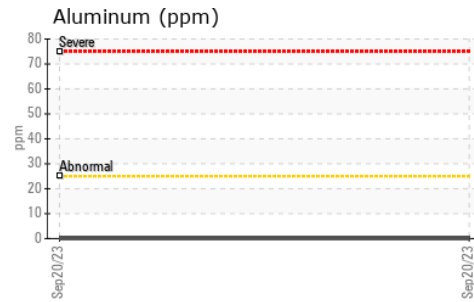
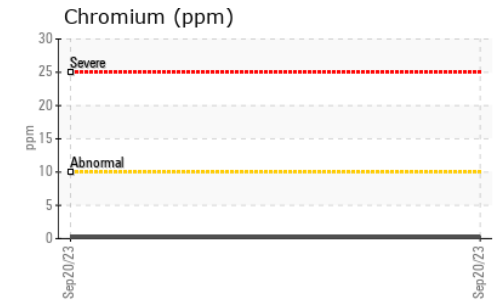
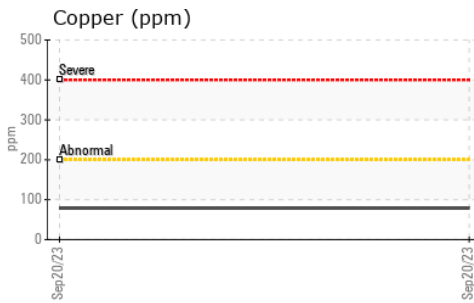
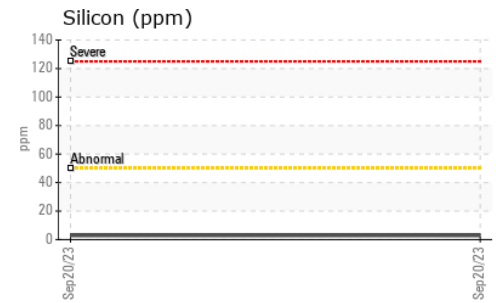
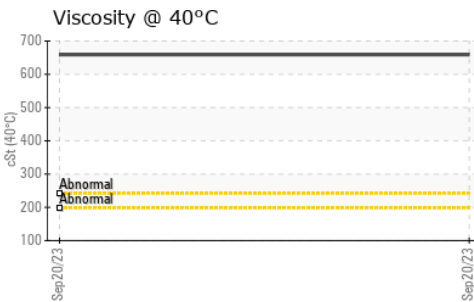
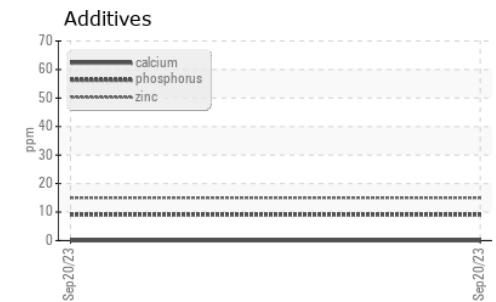
GRAPHS

All component wear rates are normal.

There is no indication of any contamination in the oil.

The condition of the oil is acceptable for the time in service.

Resample at the next service interval to monitor. Please specify the brand, type, and viscosity of the oil on your next sample.
