OIL ANALYSIS REPORT

Machine Id
NRL482
 Component
Hoisting Gearbox
 Fluid
NOT GIVEN (--- GAL)

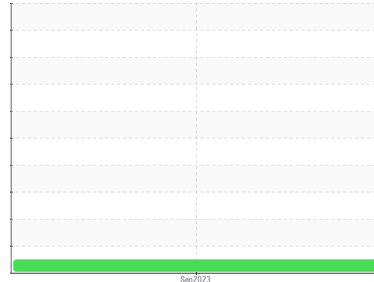
Sample Rating Trend

NORMAL

All component wear rates are normal.

There is no indication of any contamination in the oil.

The condition of the oil is acceptable for the time in service.

Resample at the next service interval to monitor.
