OIL ANALYSIS REPORT

Machine Id
F18
Component
Transmission (Auto)
Fluid
NOT GIVEN (--- GAL)

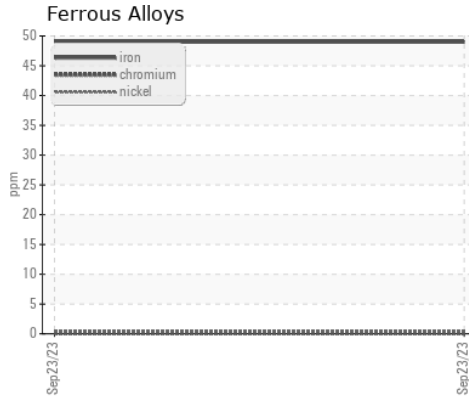
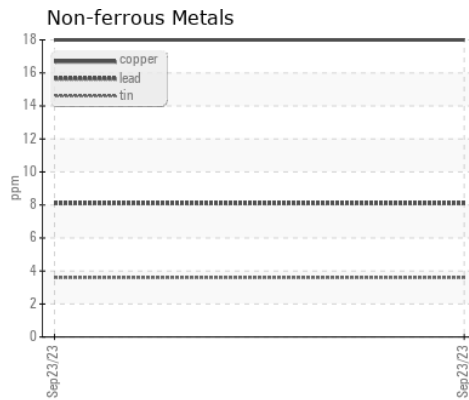
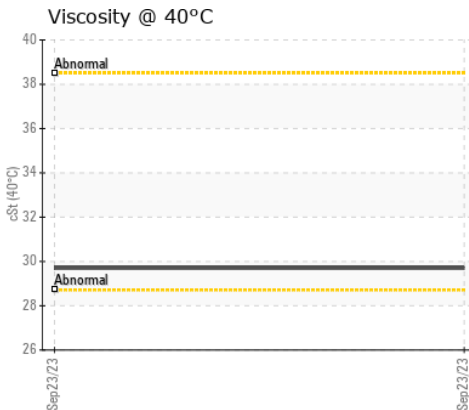
GRAPHS

Wear
All component wear rates are normal.

Contamination
There is no indication of any contamination in the fluid.

Fluid Condition
The condition of the fluid is acceptable for the time in service.

Recommendation
Resample at the next service interval to monitor.
