# PROBLEM SUMMARY

Machine Id  
**1056828 (S/N 1024)**

Component  
**Compressor**

Fluid  
**KAESER SIGMA (OEM) FG-460 (--- GAL)**

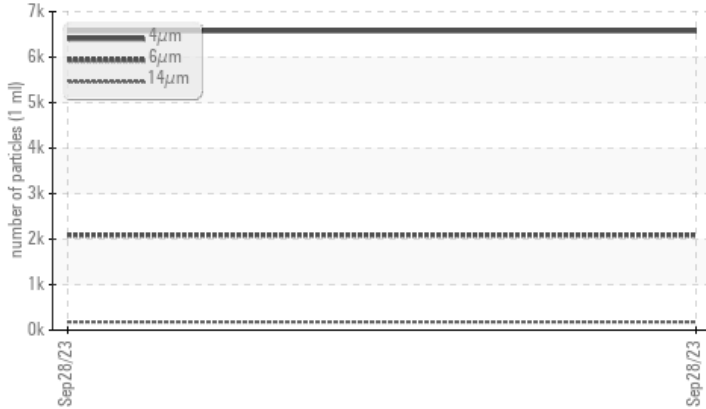
### ▲ Particle Trend

Sample Status			<b>ABNORMAL</b>	---	---
Particles >6µm	ASTM D7647	>1300	▲ <b>2088</b>	---	---
Particles >14µm	ASTM D7647	>80	▲ <b>180</b>	---	---
Particles >21µm	ASTM D7647	>20	▲ <b>44</b>	---	---
Oil Cleanliness	ISO 4406 (c)	>--/17/13	▲ <b>20/18/15</b>	---	---

There is a high amount of particulates present in the oil.

No corrective action is recommended at this time. The filter change at the time of sampling has been noted. Resample at the next service interval to monitor.
