# PROBLEM SUMMARY

Area  
**BLEACH O2**  
 Machine Id  
**METSO BX060 POST02 PRESS SE (S/N 0661-03-02-040-040)**  
 Component  
**Bearing**  
 Fluid  
**NOT GIVEN (4 GAL)**

# OIL ANALYSIS REPORT

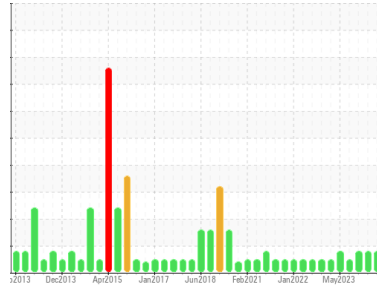
Sample Rating Trend

Sample Status				<b>MARGINAL</b>	ABNORMAL	ABNORMAL
Iron	ppm	ASTM D5185m	>20	▲ 89	▲ 85	▲ 85

No corrective action is recommended at this time.  
 Resample at the next service interval to monitor.

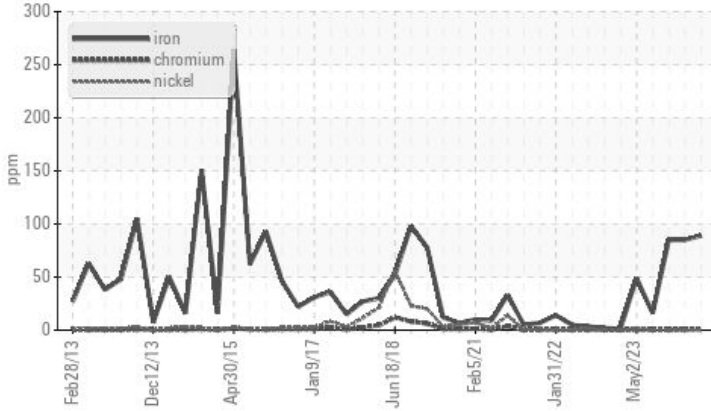
### ▲ Ferrous Alloys

The iron level is abnormal. All other component wear rates are normal.

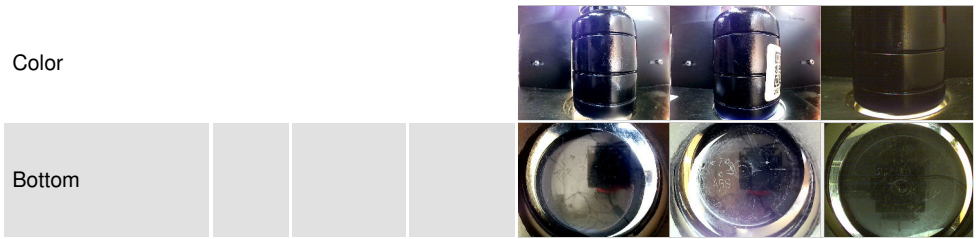
SAMPLE IMAGES	method	limit/base	current	history1	history2
---------------	--------	------------	---------	----------	----------

VISUAL	method	limit/base	current	history1	history2
White Metal	scalar	*Visual	NONE	NONE	NONE
Yellow Metal	scalar	*Visual	NONE	NONE	NONE
Precipitate	scalar	*Visual	NONE	NONE	NONE
Silt	scalar	*Visual	NONE	NONE	NONE
Debris	scalar	*Visual	NONE	NONE	NONE
Sand/Dirt	scalar	*Visual	NONE	NONE	NONE
Appearance	scalar	*Visual	NORML	NORML	NORML
Odor	scalar	*Visual	NORML	NORML	NORML
Emulsified Water	scalar	*Visual	>2	0.2%	NEG
Free Water	scalar	*Visual		NEG	NEG

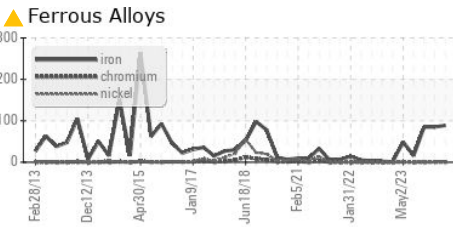
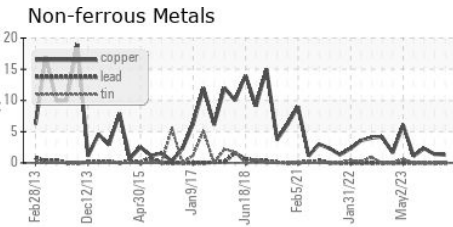
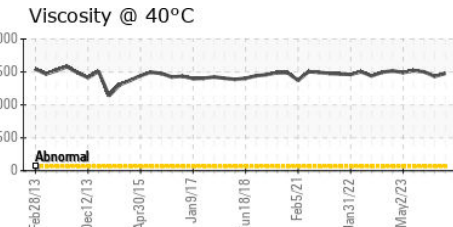
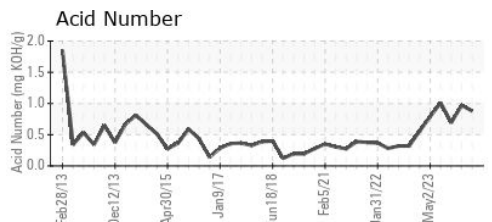
## GRAPHS

method	limit/base	current	history1	history2
Iron	ppm	ASTM D5185m >20	<b>▲ 89</b>	▲ 85	▲ 85
Chromium	ppm	ASTM D5185m >20	<b>&lt;1</b>	<1	<1
Nickel	ppm	ASTM D5185m >20	<b>&lt;1</b>	0	<1
Titanium	ppm	ASTM D5185m	<b>0</b>	0	0
Silver	ppm	ASTM D5185m	<b>0</b>	0	0
Aluminum	ppm	ASTM D5185m >20	<b>0</b>	<1	<1
Lead	ppm	ASTM D5185m >20	<b>0</b>	0	0
Copper	ppm	ASTM D5185m >20	<b>1</b>	1	2
Tin	ppm	ASTM D5185m >20	<b>0</b>	0	0
Vanadium	ppm	ASTM D5185m	<b>0</b>	<1	<1
Cadmium	ppm	ASTM D5185m	<b>0</b>	0	0
