PROBLEM SUMMARY

Machine Id
WIRTGEN W210FI 23200362
Component
Hydraulic System
Fluid
AW HYDRAULIC OIL ISO 46 (--- GAL)

OIL ANALYSIS REPORT

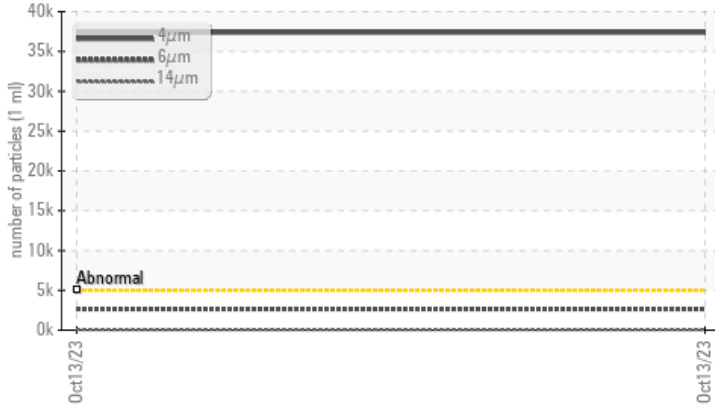
▲ Particle Trend

Sample Status			ABNORMAL	---	---
Particles >4µm	ASTM D7647	>5000	▲ 37383	---	---
Particles >6µm	ASTM D7647	>1300	▲ 2656	---	---
Oil Cleanliness	ISO 4406 (c)	>19/17/14	▲ 22/19/13	---	---

There is a moderate amount of silt (particulates < 14 microns in size) present in the oil.

We recommend you service the filters on this component. We recommend an early resample to monitor this condition. Please specify the brand, type, and viscosity of the oil on your next sample.

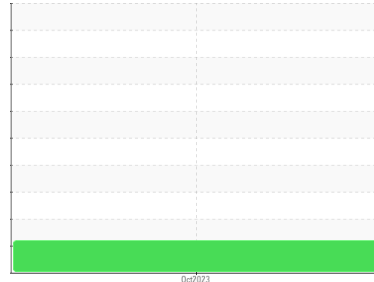
DIAGNOSIS
▲ Recommendation

We recommend you service the filters on this component. We recommend an early resample to monitor this condition. Please specify the brand, type, and viscosity of the oil on your next sample.

The AN level is acceptable for this fluid. The oil is still serviceable provided that the contaminant(s) can be reduced to acceptable levels.

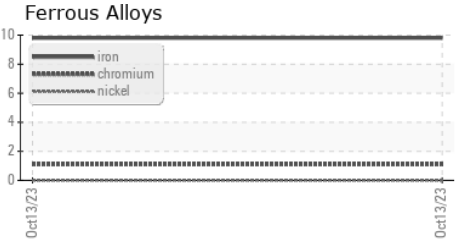
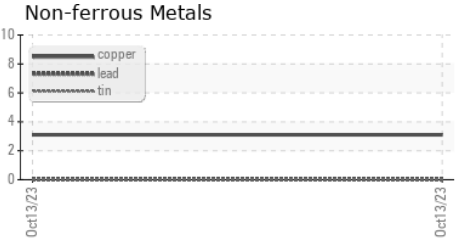
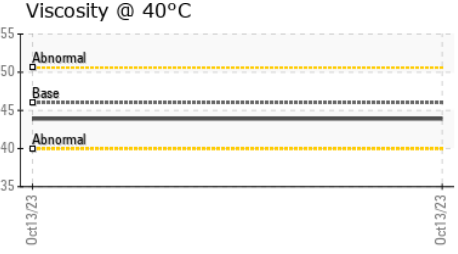
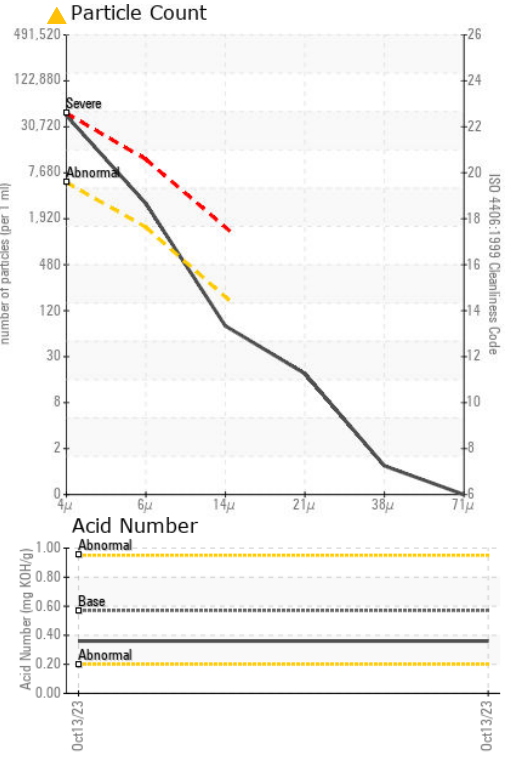
GRAPHS

method	limit/base	current	history1	history2
Particles >4µm	ASTM D7647	>5000	▲ 37383	---	---
Particles >6µm	ASTM D7647	>1300	▲ 2656	---	---
Particles >14µm	ASTM D7647	>160	67	---	---
Particles >21µm	ASTM D7647	>40	16	---	---
Particles >38µm	ASTM D7647	>10	1	---	---
Particles >71µm	ASTM D7647	>3	0	---	---
Oil Cleanliness	ISO 4406 (c)	>19/17/14	▲ 22/19/13	---	---
