# PROBLEM SUMMARY

Area  
**GOLDEN BEAR**  
Machine Id  
**MRC-271**  
Component  
**Natural Gas Engine**  
Fluid  
**LO-ASH ENGINE OIL SAE 40 (--- GAL)**

# OIL ANALYSIS REPORT

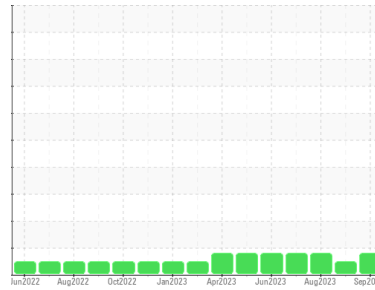
Sample Rating Trend

Sample Status				<b>ABNORMAL</b>	NORMAL	MARGINAL
Lead	ppm	ASTM D5185m	>30	<b>▲ 31</b>	28	▲ 31

No corrective action is recommended at this time.  
Resample at the next service interval to monitor.

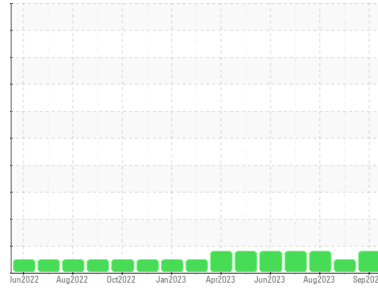
Sample Rating Trend

**Wear**  
Bearing and/or bushing wear is indicated.

**Contamination**  
There is no indication of any contamination in the oil.

**Fluid Condition**  
The BN result indicates that there is suitable alkalinity remaining in the oil. The AN level is acceptable for this fluid. The condition of the oil is suitable for further service.

**Recommendation**  
No corrective action is recommended at this time. Resample at the next service interval to monitor.
