OIL ANALYSIS REPORT

Area
[73386432]
 Machine Id
6530203 (S/N 1218)

Component
Compressor
 Fluid
KAESER SIGMA (OEM) M-460 (--- GAL)

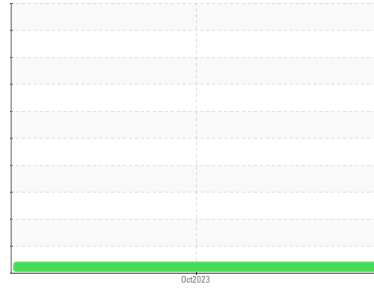
Sample Rating Trend

VIS DEBRIS

Sample Status				ABNORMAL	---	---
Debris	scalar	*Visual	NONE	▲ MODER	---	---

No corrective action is recommended at this time. The filter change at the time of sampling has been noted. Resample at the next service interval to monitor. We were unable to perform a particle count due to a high concentration of particles present in this sample.
