OIL ANALYSIS REPORT

Machine Id
ELGI AC 3 (S/N MQKS030036)

Component
Air Compressor

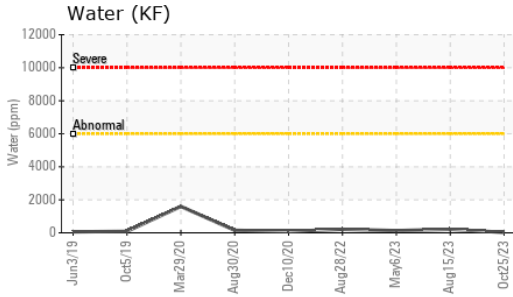
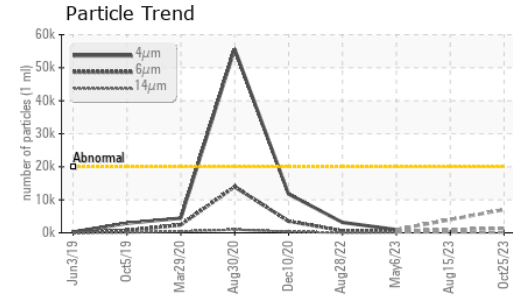
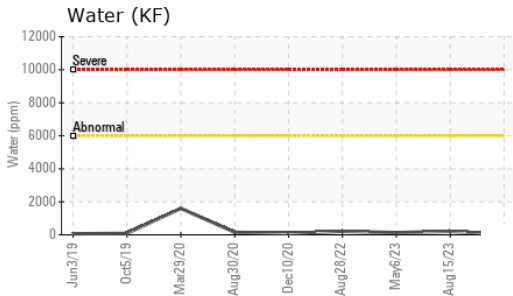
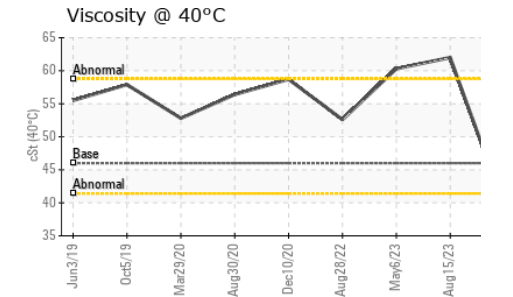
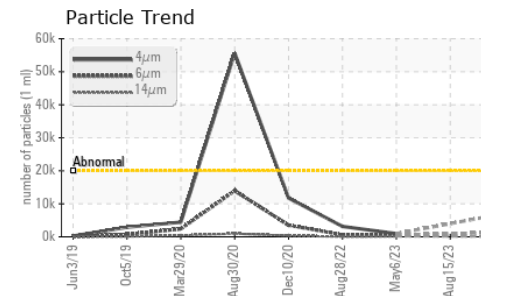
All component wear rates are normal.

There is no indication of any contamination in the oil. The amount and size of particulates present in the system are acceptable.

A decrease in the viscosity is noted. Confirmed. The AN level is acceptable for this fluid. The condition of the oil is suitable for further service.

Resample at the next service interval to monitor.
