# PROBLEM SUMMARY

Machine Id  
**HOMOGENIZER 8NA**  
Component  
**Gearbox**  
Fluid  
**PETRO CANADA PURITY FG SYNTH EP GEAR 220 (--- LTR)**

# OIL ANALYSIS REPORT

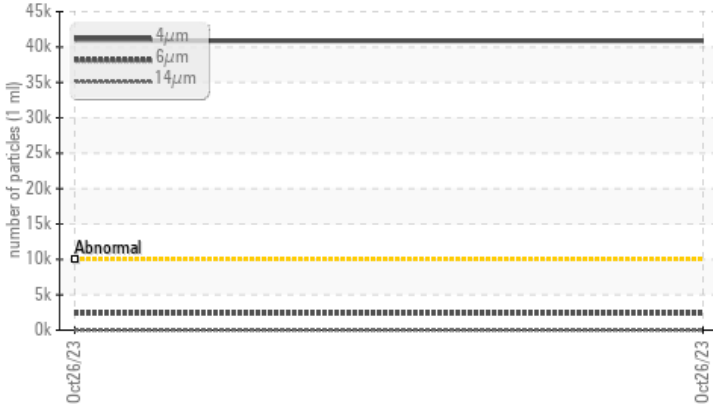
### ▲ Particle Trend

Sample Status			<b>ABNORMAL</b>	---	---
Particles >4µm	ASTM D7647	>10000	▲ <b>40865</b>	---	---
Oil Cleanliness	ISO 4406 (c)	>20/18/16	▲ <b>23/18/11</b>	---	---

Resample at the next service interval to monitor.
