# PROBLEM SUMMARY

Area  
**ENGINE ROOM**  
Machine Id  
**MYCOM C07-1 (S/N 2535284)**  
Component  
**Refrigeration Compressor**  
Fluid  
**FRICK COMPRESSOR OIL #3 (--- PNT)**

# OIL ANALYSIS REPORT

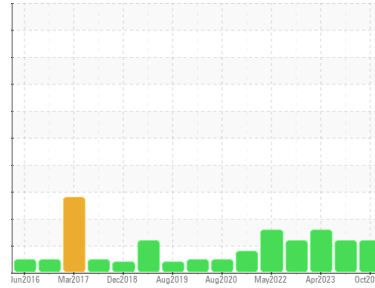
## Sample Rating Trend

Sample Status			ATTENTION	ABNORMAL	ABNORMAL
Particles >4µm	ASTM D7647	>10000	▲ 14912	▲ 23641	577
Particles >6µm	ASTM D7647	>2500	▲ 2570	▲ 3771	123
Oil Cleanliness	ISO 4406 (c)	>20/18/15	▲ 21/19/13	▲ 22/19/14	16/14/11

Resample at the next service interval to monitor.

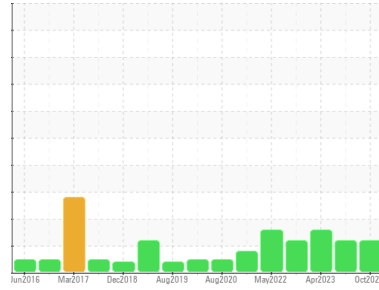
Sample Rating Trend

ISO

There is a moderate amount of silt (particulates < 14 microns in size) present in the oil.

Resample at the next service interval to monitor.

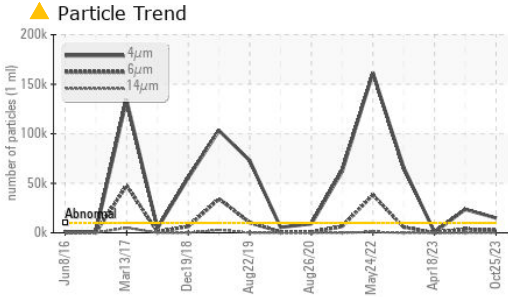
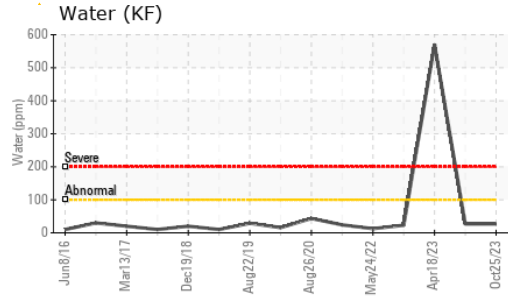
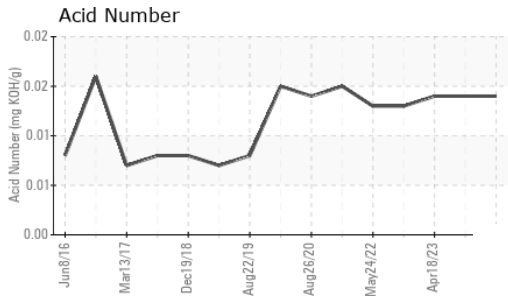
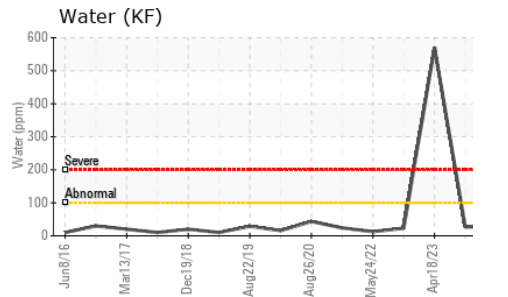
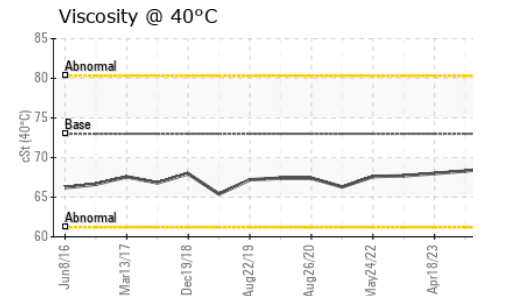
SAMPLE IMAGES	method	limit/base	current	history1	history2
Color					
Bottom

VISUAL	method	limit/base	current	history1	history2
White Metal	scalar	*Visual	NONE	NONE	NONE
Yellow Metal	scalar	*Visual	NONE	NONE	NONE
Precipitate	scalar	*Visual	NONE	NONE	NONE
Silt	scalar	*Visual	NONE	NONE	NONE
Debris	scalar	*Visual	NONE	NONE	LIGHT
Sand/Dirt	scalar	*Visual	NONE	NONE	NONE
Appearance	scalar	*Visual	NORML	NORML	NORML
Odor	scalar	*Visual	NORML	NORML	NORML
Emulsified Water	scalar	*Visual	>0.01	NEG	▲ 0.2%
Free Water	scalar	*Visual		NEG	NEG
