OIL ANALYSIS REPORT

Area
OKLAHOMA/102/EG - MOTOR GRADER
 Machine Id
78.264 [OKLAHOMA^102^EG - MOTOR GRADER]
 Component
Rear Right Drive Chain Case
 Fluid
SAE 50W (--- GAL)

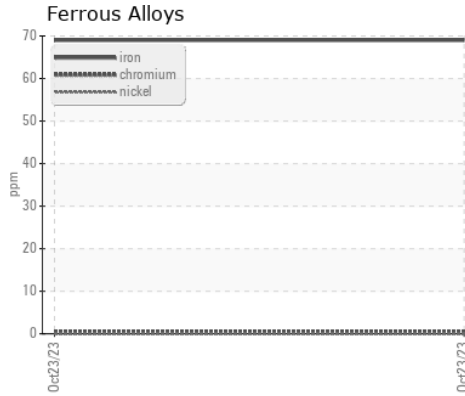
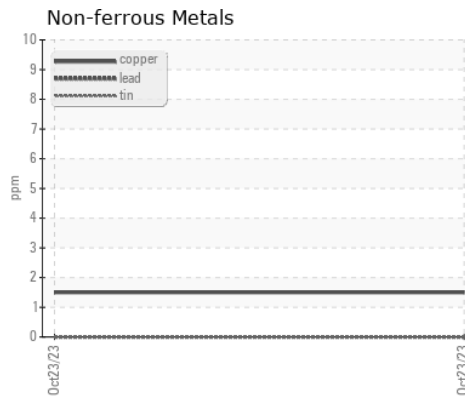
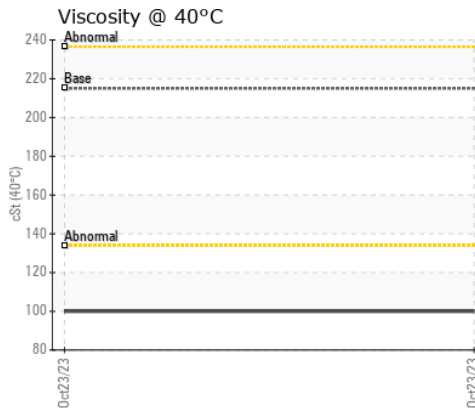
GRAPHS

All component wear rates are normal.

There is no indication of any contamination in the oil.

Confirm oil type. The condition of the oil is acceptable for the time in service.

Resample at the next service interval to monitor.
