# PROBLEM SUMMARY

Area  
**[187073-N2STV4W]**  
 Machine Id  
**TEST STAND 95**  
 Component  
**Hydraulic System**  
 Fluid  
**SHELL TELLUS 32 (250 GAL)**

# OIL ANALYSIS REPORT

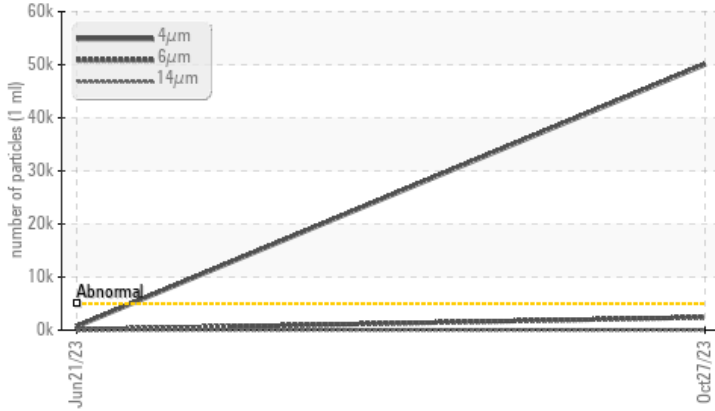
▲ Particle Trend

Sample Status			ABNORMAL	NORMAL	---
Particles >4µm	ASTM D7647	>5000	▲ 50033	683	---
Particles >6µm	ASTM D7647	>1300	▲ 2412	108	---
Oil Cleanliness	ISO 4406 (c)	>19/17/14	▲ 23/18/12	17/14/12	---

No corrective action is recommended at this time.  
 Resample at the next service interval to monitor.

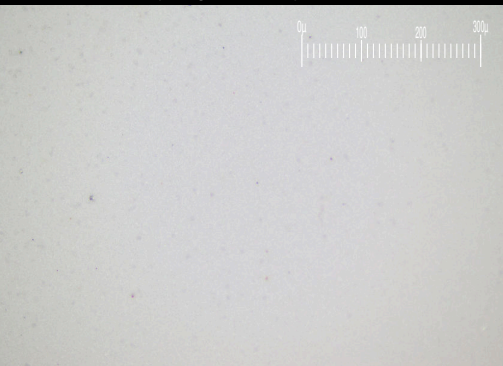
Particle Filter (Magn: 200 x)

There is a high amount of silt (particulates < 14 microns in size) present in the oil.

FLUID CLEANLINESS	method	limit/base	current	history1	history2
Particles >4µm	ASTM D7647	>5000	<b>▲ 50033</b>	683	---
Particles >6µm	ASTM D7647	>1300	<b>▲ 2412</b>	108	---
Particles >14µm	ASTM D7647	>160	<b>27</b>	22	---
Particles >21µm	ASTM D7647	>40	<b>3</b>	4	---
Particles >38µm	ASTM D7647	>10	<b>0</b>	0	---
Particles >71µm	ASTM D7647	>3	<b>0</b>	0	---
Oil Cleanliness	ISO 4406 (c)	>19/17/14	<b>▲ 23/18/12</b>	17/14/12	---

No corrective action is recommended at this time. Resample at the next service interval to monitor.
