# PROBLEM SUMMARY

Machine Id  
**3057932 (S/N 1267)**

Component  
**Compressor**

Fluid  
**KAESER SIGMA (OEM) M-460 (--- GAL)**

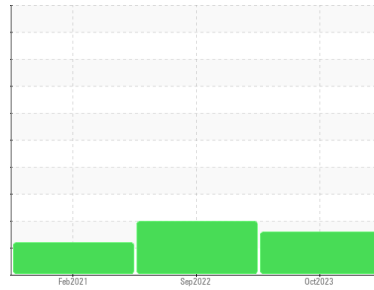
## Sample Rating Trend

All component wear rates are normal.

There is a high amount of particulates present in the oil.

The AN level is acceptable for this fluid. The condition of the oil is suitable for further service.

No corrective action is recommended at this time. The filter change at the time of sampling has been noted. Resample at the next service interval to monitor.

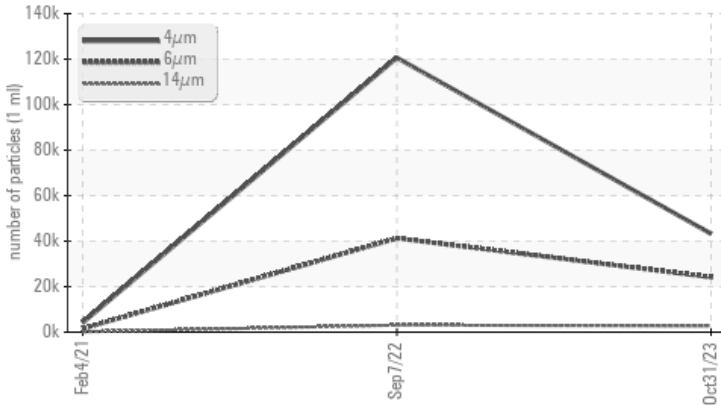
### ▲ Particle Trend

| Sample Status | | | ABNORMAL | ABNORMAL | ATTENTION |
|---|---|---|---|---|---|
| Particles >6µm | ASTM D7647 | >1300 | ▲ <b>24157</b> | ▲ 41279 | ▲ 1513 |
| Particles >14µm | ASTM D7647 | >80 | ▲ <b>2744</b> | ▲ 3071 | ▲ 138 |
| Particles >21µm | ASTM D7647 | >20 | ▲ <b>438</b> | ▲ 690 | ▲ 32 |
| Oil Cleanliness | ISO 4406 (c) | >--/17/13 | ▲ <b>23/22/19</b> | ▲ 24/23/19 | ▲ 18/14 |
