Machine Id
T-3 SOUTH VAC MILL (SOUTH PLANT)

Component
Agitator Gearbox

Fluid
JAX MAGNA-PLATE 220 FG (--- GAL)

OIL ANALYSIS REPORT

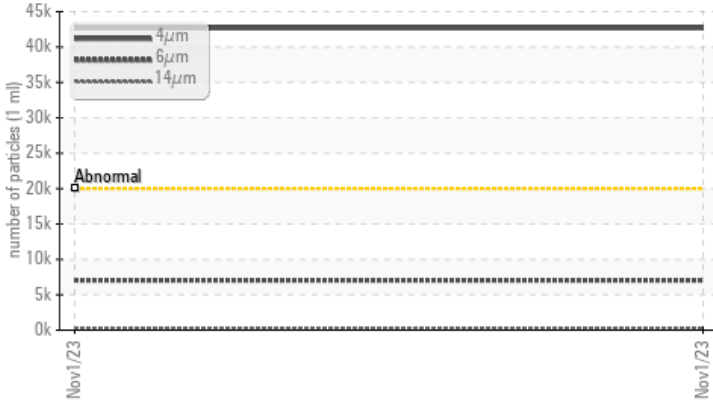
▲ Particle Trend

Sample Status			ABNORMAL	---	---
Particles >4µm	ASTM D7647	>20000	▲ 42673	---	---
Particles >6µm	ASTM D7647	>5000	▲ 7037	---	---
Oil Cleanliness	ISO 4406 (c)	>21/19/16	▲ 23/20/15	---	---

There is a high amount of silt (particulates < 14 microns in size) present in the oil.

Resample at the next service interval to monitor.
