Machine Id **GRINDER 1 (SOUTH PLANT)**

Component
Gearbox

Fluid
JAX MAGNA-PLATE 220 FG (--- GAL)

OIL ANALYSIS REPORT

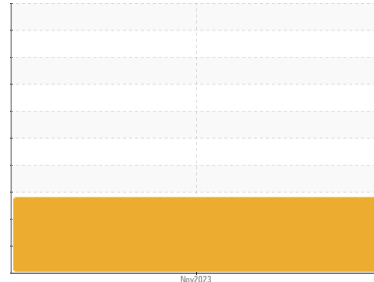
Sample Rating Trend

WATER

▲ Water (KF)

Sample Status				ABNORMAL	---	---
Water	%	ASTM D6304	>0.2	▲ 0.391	---	---
ppm Water	ppm	ASTM D6304	>2000	▲ 3910	---	---
Debris	scalar	*Visual	NONE	▲ MODER	---	---
Appearance	scalar	*Visual	NORML	▲ HAZY	---	---

We recommend you service the filters on this component if applicable. Resample at the next service interval to monitor. We were unable to perform a particle count due to a high concentration of particles present in this sample.

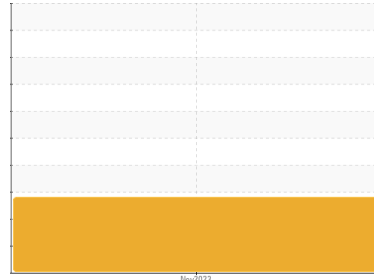
Sample Rating Trend

WATER

Appearance is hazy. Moderate concentration of visible dirt/debris present in the oil. There is a light concentration of water present in the oil.

We recommend you service the filters on this component if applicable. Resample at the next service interval to monitor. We were unable to perform a particle count due to a high concentration of particles present in this sample.

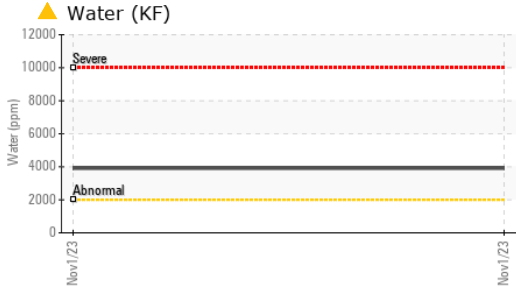
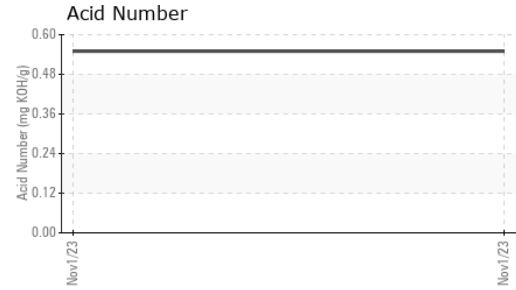
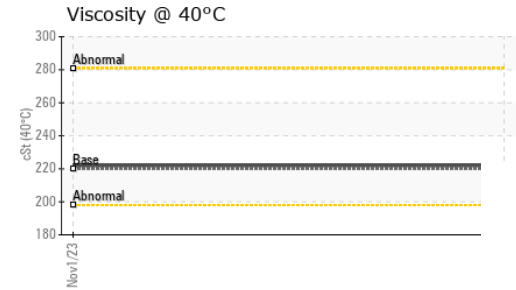
VISUAL	method	limit/base	current	history1	history2	
White Metal	scalar	*Visual	NONE	NONE	---	---
Yellow Metal	scalar	*Visual	NONE	NONE	---	---
Precipitate	scalar	*Visual	NONE	NONE	---	---
Silt	scalar	*Visual	NONE	NONE	---	---
Debris	scalar	*Visual	NONE	▲ MODER	---	---
Sand/Dirt	scalar	*Visual	NONE	NONE	---	---
Appearance	scalar	*Visual	NORML	▲ HAZY	---	---
Odor	scalar	*Visual	NORML	NORML	---	---
Emulsified Water	scalar	*Visual	>0.2	0.2%	---	---
Free Water	scalar	*Visual		NEG	---	---
