Machine Id
T-1 BLENDER WEST (SOUTH PLANT)

Component
Gearbox

Fluid
JAX MAGNA-PLATE 220 FG (--- GAL)

OIL ANALYSIS REPORT

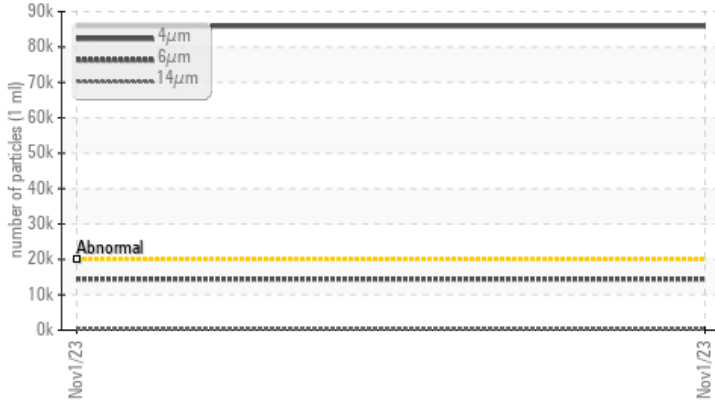
▲ Particle Trend

Sample Status			ABNORMAL	---	---
Particles >4µm	ASTM D7647	>20000	▲ 85911	---	---
Particles >6µm	ASTM D7647	>5000	▲ 14435	---	---
Oil Cleanliness	ISO 4406 (c)	>21/19/16	▲ 24/21/15	---	---

There is a high amount of silt (particulates < 14 microns in size) present in the oil.

Resample at the next service interval to monitor.
