Machine Id INCLINE PRE-BLEND 1 (SOUTH PLANT)

Component
Gearbox
Fluid

JAX MAGNA-PLATE 220 FG (--- GAL)

OIL ANALYSIS REPORT

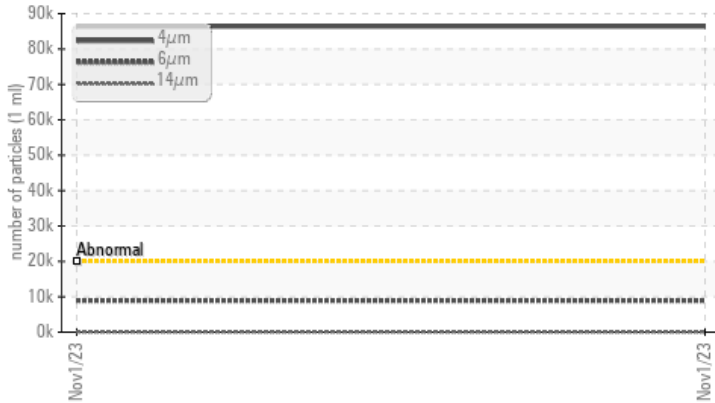
▲ Particle Trend

Sample Status				ABNORMAL	---	---
Particles >4µm	ASTM D7647	>20000	▲ 86388	---	---	---
Particles >6µm	ASTM D7647	>5000	▲ 8909	---	---	---
Oil Cleanliness	ISO 4406 (c)	>21/19/16	▲ 24/20/13	---	---	---

There is a high amount of silt (particulates < 14 microns in size) present in the oil.

Resample at the next service interval to monitor.
