Machine Id
T-2 VAC MILL (SOUTH PLANT)

Component
Agitator Gearbox

Fluid
JAX MAGNA-PLATE 220 FG (--- GAL)

OIL ANALYSIS REPORT

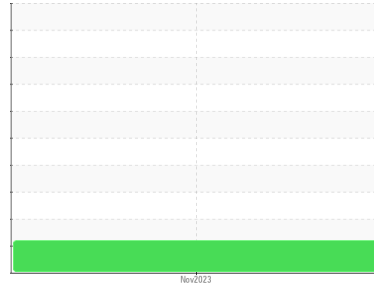
Sample Rating Trend

▲ Particle Trend

Sample Status			ABNORMAL	---	---
Particles >4µm	ASTM D7647	>20000	▲ 80311	---	---
Particles >6µm	ASTM D7647	>5000	▲ 11411	---	---
Oil Cleanliness	ISO 4406 (c)	>21/19/16	▲ 24/21/15	---	---

Resample at the next service interval to monitor.

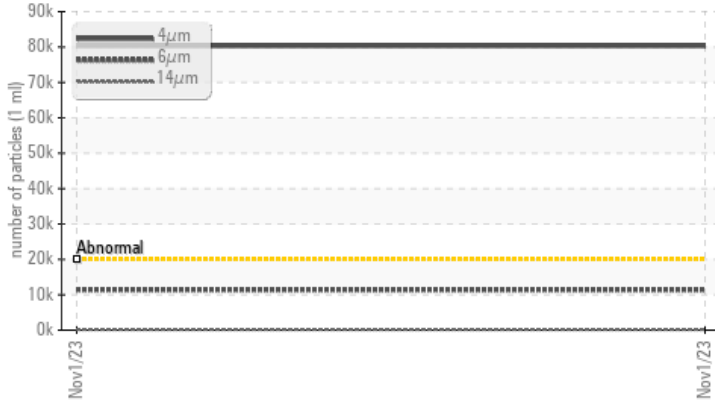
There is a high amount of silt (particulates < 14 microns in size) present in the oil.
