Machine Id  
**PRE-BLEND 1 EAST (SOUTH PLANT)**

Component  
**Gearbox**

Fluid  
**JAX MAGNA-PLATE 220 FG (--- GAL)**

# OIL ANALYSIS REPORT

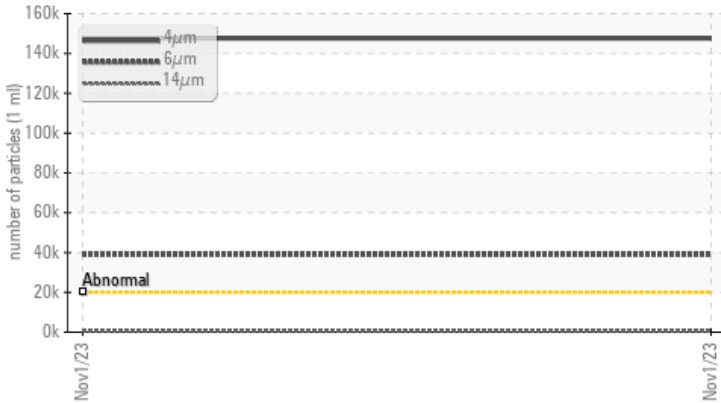
### ▲ Particle Trend

Sample Status			<b>ABNORMAL</b>	---	---
Particles >4µm	ASTM D7647	>20000	▲ <b>147549</b>	---	---
Particles >6µm	ASTM D7647	>5000	▲ <b>38938</b>	---	---
Oil Cleanliness	ISO 4406 (c)	>21/19/16	▲ <b>24/22/16</b>	---	---

There is a high amount of silt (particulates < 14 microns in size) present in the oil.

Resample at the next service interval to monitor.
