Machine Id  
**T-1 SILO (SOUTH PLANT)**

Component  
**Gearbox**

Fluid  
**JAX MAGNA-PLATE 220 FG (--- GAL)**

# OIL ANALYSIS REPORT

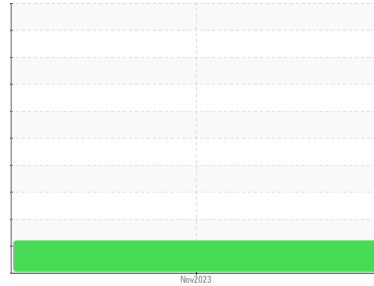
Sample Rating Trend

Sample Status			<b>ABNORMAL</b>	---	---
Particles >4µm	ASTM D7647	>20000	▲ <b>79428</b>	---	---
Particles >6µm	ASTM D7647	>5000	▲ <b>15849</b>	---	---
Oil Cleanliness	ISO 4406 (c)	>21/19/16	▲ <b>23/21/15</b>	---	---

Resample at the next service interval to monitor.

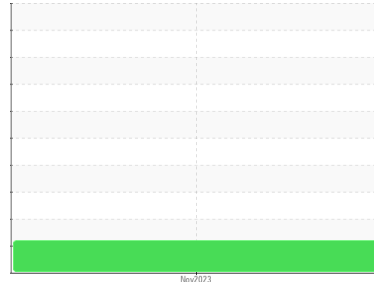
Sample Rating Trend

All component wear rates are normal.

The AN level is acceptable for this fluid. The condition of the oil is suitable for further service.
