Machine Id
T-3 BLENDER SOUTH (SOUTH PLANT)

Component
Gearbox

Fluid
JAX MAGNA-PLATE 220 FG (--- GAL)

OIL ANALYSIS REPORT

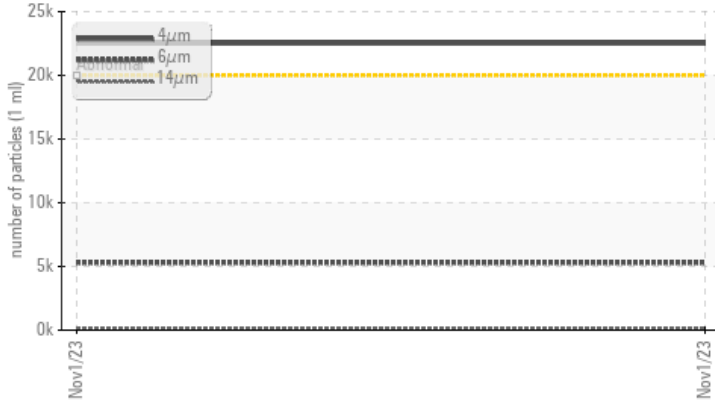
▲ Particle Trend

Sample Status				ATTENTION	---	---
Particles >4µm	ASTM D7647	>20000	▲ 22508	---	---	---
Particles >6µm	ASTM D7647	>5000	▲ 5301	---	---	---
Oil Cleanliness	ISO 4406 (c)	>21/19/16	▲ 22/20/15	---	---	---
Appearance	scalar *Visual	NORML	▲ HAZY	---	---	---

There is a moderate amount of silt (particulates < 14 microns in size) present in the oil.

Resample at the next service interval to monitor.
