# PROBLEM SUMMARY

Machine Id  
**RC-9 (S/N 0152)**  
 Component  
**Refrigeration Compressor**  
 Fluid  
**FRICK COMPRESSOR OIL #11 (--- GAL)**

# OIL ANALYSIS REPORT

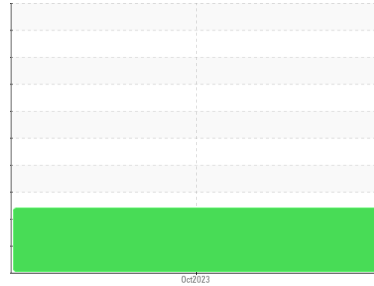
Sample Rating Trend

DEGRADATION

Sample Status				ABNORMAL	---	---
Iron	ppm	ASTM D5185m	>8	▲ 60	---	---
Acid Number (AN)	mg KOH/g	ASTM D974		▲ 0.577	---	---
Debris	scalar	*Visual	NONE	▲ MODER	---	---

We recommend you service the filters on this component. Resample at the next service interval to monitor. We were unable to perform a particle count due to a high concentration of particles present in this sample.

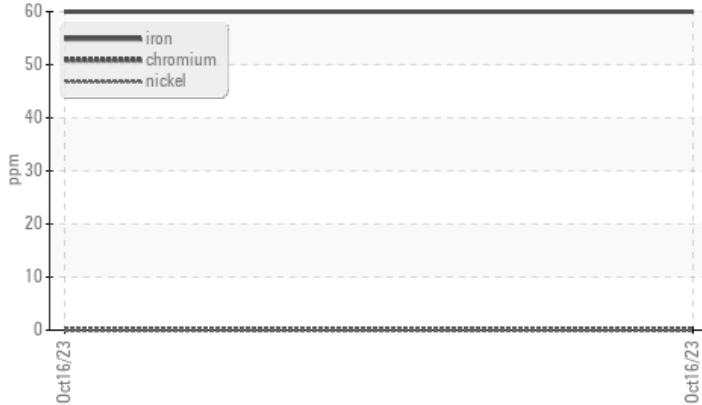
### ▲ Ferrous Alloys

The iron level is abnormal.

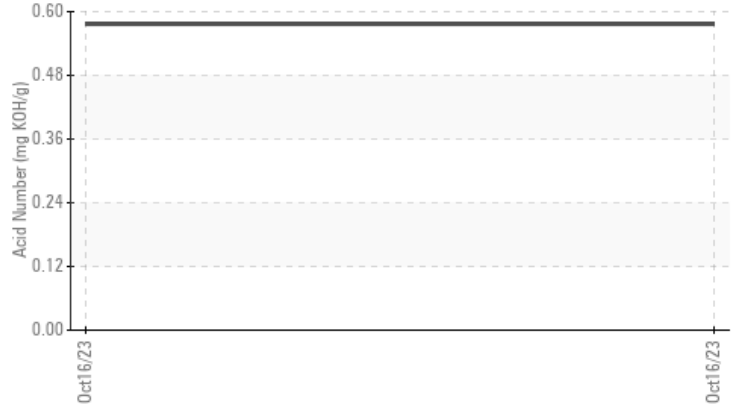
### ▲ Acid Number

The AN level is above the recommended limit. Confirmed. Confirm oil type.

method	limit/base	current	history1	history2
Acid Number (AN)	mg KOH/g	ASTM D974	<b>▲ 0.577</b>	---	---

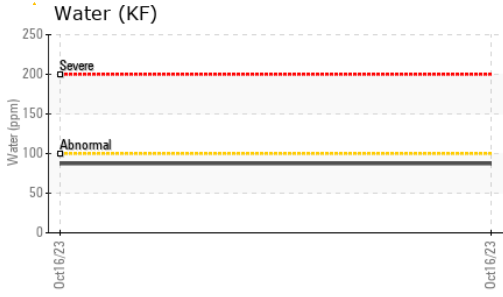
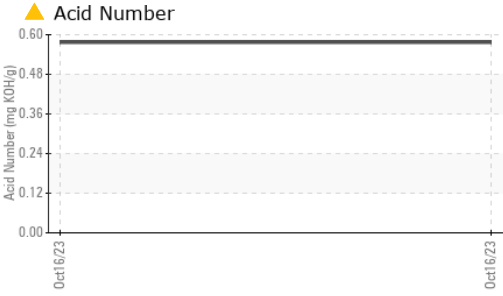
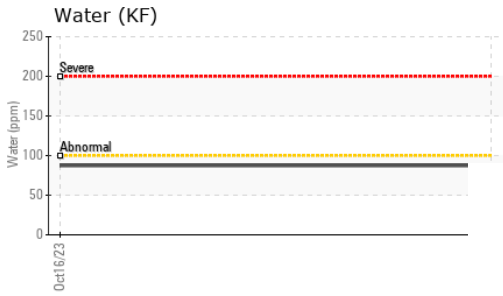
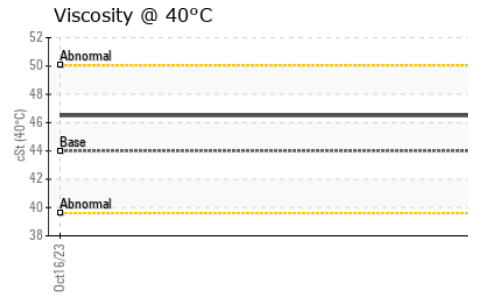
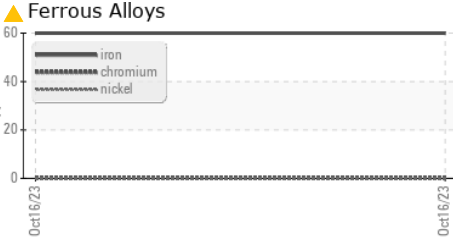
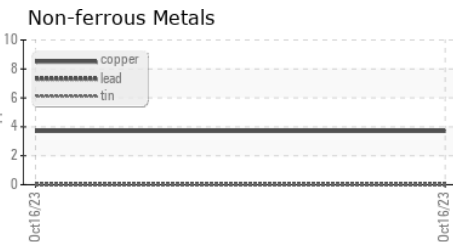
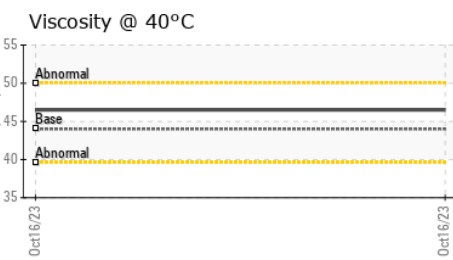
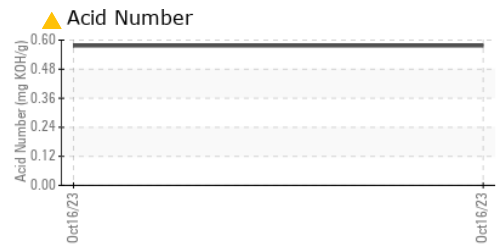
### GRAPHS

Moderate concentration of visible dirt/debris present in the oil.

We recommend you service the filters on this component. Resample at the next service interval to monitor. We were unable to perform a particle count due to a high concentration of particles present in this sample.
