# PROBLEM SUMMARY

Machine Id  
**RC-6 (S/N 10240C92432845)**  
 Component  
**Refrigeration Compressor**  
 Fluid  
**FRICK COMPRESSOR OIL #11 (--- GAL)**

# OIL ANALYSIS REPORT

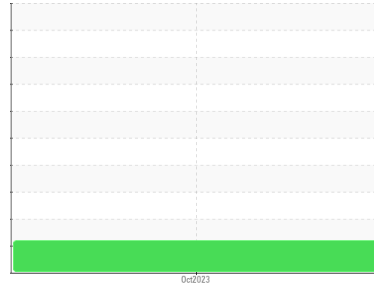
WEAR

Sample Status	ASTM D5185m	>8	ABNORMAL	---	---
Iron	ppm	ASTM D5185m	>8	▲ 82	---
Debris	scalar	*Visual	NONE	▲ MODER	---

We recommend you service the filters on this component. We recommend an early resample to monitor this condition. We were unable to perform a particle count due to a high concentration of particles present in this sample.

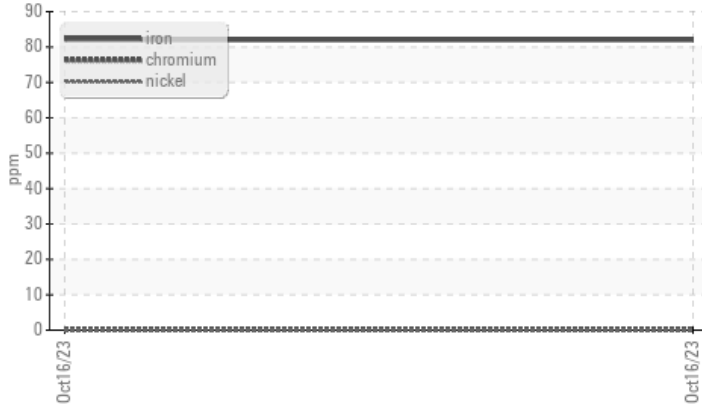
### ▲ Ferrous Alloys

The iron level is abnormal.
