Machine Id
FRICK 100-C-401A
Component
Rotary Compressor
Fluid
FRICK 19 (--- GAL)

Customer Id: ETCNDLD
Sample No.: TO90003096
Lab Number: 05996788
Test Package: IND 2

OIL ANALYSIS REPORT

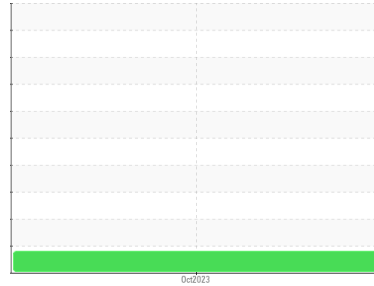
Sample Rating Trend

Sample Status			ATTENTION	---	---
Particles >4µm	ASTM D7647	>10000	▲ 11889	---	---
Oil Cleanliness	ISO 4406 (c)	>20/18/15	▲ 21/18/13	---	---

No corrective action is recommended at this time.
Resample at the next service interval to monitor.

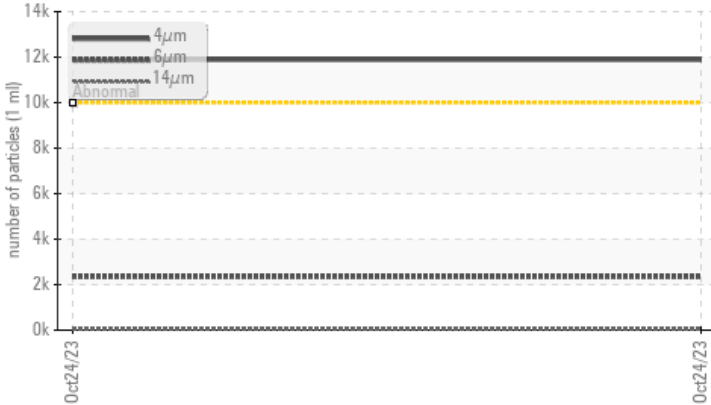
▲ Particle Trend

There is a moderate amount of silt (particulates < 14 microns in size) present in the oil.
