Customer Id: HORMCC
 Sample No.: WC0850234
 Lab Number: 05997921
 Test Package: IND 2

OIL ANALYSIS REPORT

Area
INTERSTITIAL - PUMP ROOM
 Machine Id
B64247 - 5B (S/N 083012-1015943-001-24146-000)
 Component
Hydraulic Power Pack
 Fluid
AW HYDRAULIC OIL ISO 46 (--- GAL)

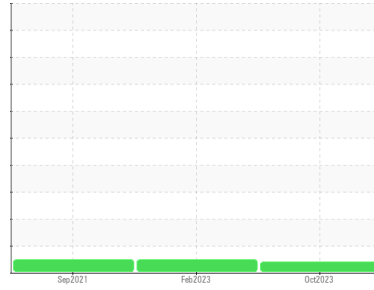
Sample Rating Trend

VIS DEBRIS

Sample Status				ABNORMAL	NORMAL	NORMAL
Debris	scalar	*Visual	NONE	▲ MODER	NONE	NONE

Moderate concentration of visible dirt/debris present in the oil.

We recommend you service the filters on this component. Resample at the next service interval to monitor. We were unable to perform a particle count due to a high concentration of particles present in this sample.

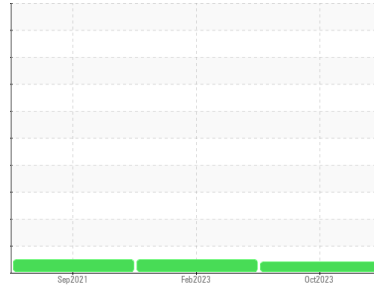
Sample Rating Trend

VIS DEBRIS

We recommend you service the filters on this component. Resample at the next service interval to monitor. We were unable to perform a particle count due to a high concentration of particles present in this sample.

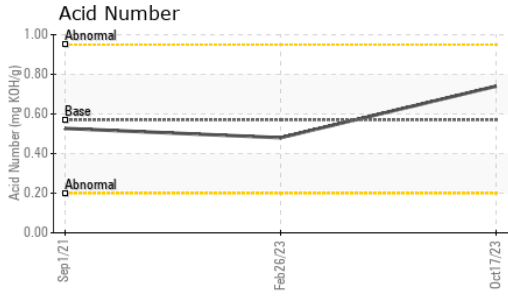
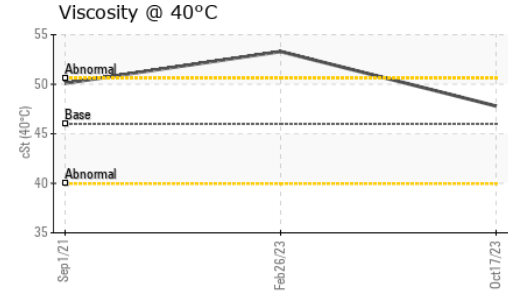
VISUAL	method	limit/base	current	history1	history2
White Metal	scalar	*Visual	NONE	NONE	NONE
Yellow Metal	scalar	*Visual	NONE	NONE	NONE
Precipitate	scalar	*Visual	NONE	NONE	NONE
Silt	scalar	*Visual	NONE	NONE	NONE
Debris	scalar	*Visual	▲ MODER	NONE	NONE
Sand/Dirt	scalar	*Visual	NONE	NONE	NONE
Appearance	scalar	*Visual	NORML	NORML	NORML
Odor	scalar	*Visual	NORML	NORML	NORML
Emulsified Water	scalar	*Visual	>0.05	NEG	NEG
Free Water	scalar	*Visual		NEG	NEG

FLUID PROPERTIES	method	limit/base	current	history1	history2
Visc @ 40°C	cSt	ASTM D445 46	47.8	53.3	50.1

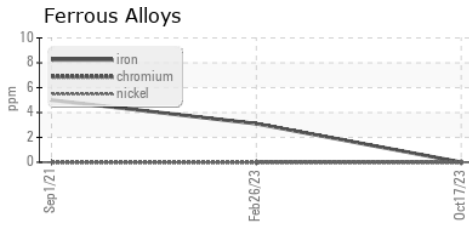
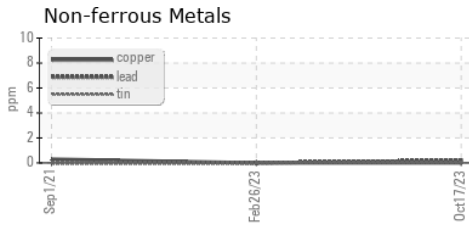
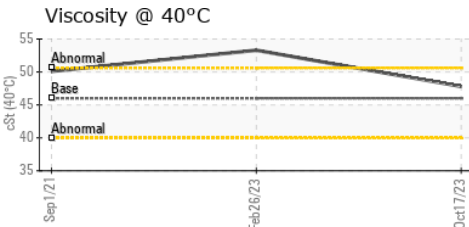
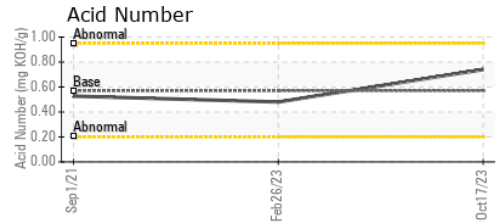
GRAPHS

method	limit/base	current	history1	history2
Particles >4µm	ASTM D7647	>5000	---	1715	1382
Particles >6µm	ASTM D7647	>1300	---	428	322
Particles >14µm	ASTM D7647	>160	---	31	25
Particles >21µm	ASTM D7647	>40	---	5	4
Particles >38µm	ASTM D7647	>10	---	0	0
Particles >71µm	ASTM D7647	>3	---	0	0
Oil Cleanliness	ISO 4406 (c)	>19/17/14	---	18/16/12	18/16/12
