OIL ANALYSIS REPORT

Area
CTL74
 Machine Id
CTL 74 EDGE TRIMMER MAIN O/S
 Component
Gearbox
 Fluid
ESSO SPARTAN EP 220 (20 GAL)

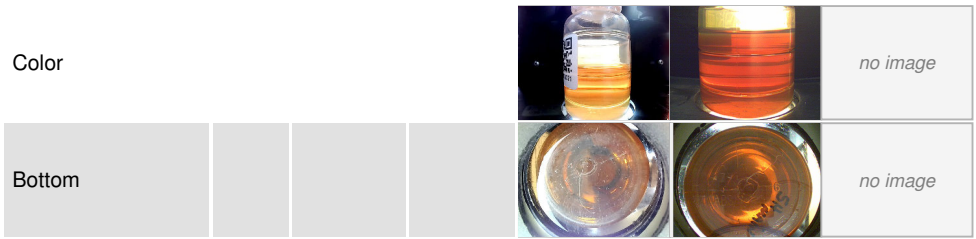
SAMPLE IMAGES	method	limit/base	current	history1	history2
---------------	--------	------------	---------	----------	----------

VISUAL	method	limit/base	current	history1	history2
White Metal	scalar	*Visual	NONE	NONE	---
Yellow Metal	scalar	*Visual	NONE	NONE	---
Precipitate	scalar	*Visual	NONE	NONE	---
Silt	scalar	*Visual	NONE	NONE	---
Debris	scalar	*Visual	NONE	NONE	LIGHT
Sand/Dirt	scalar	*Visual	NONE	NONE	---
Appearance	scalar	*Visual	NORML	NORML	---
Odor	scalar	*Visual	NORML	NORML	---
Emulsified Water	scalar	*Visual	>0.2	NEG	---
Free Water	scalar	*Visual		NEG	---

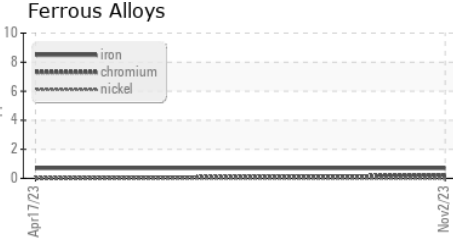
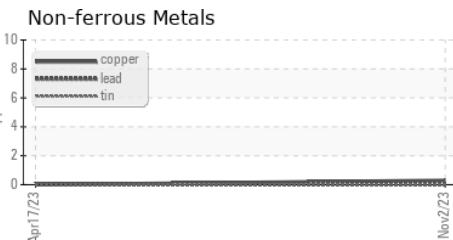
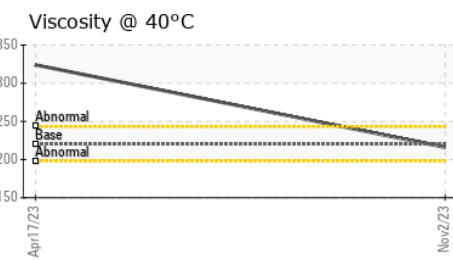
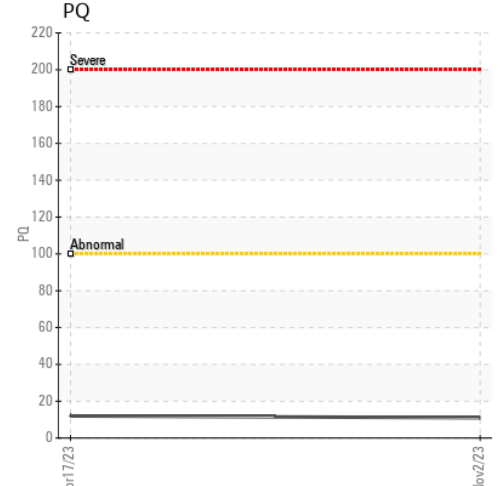
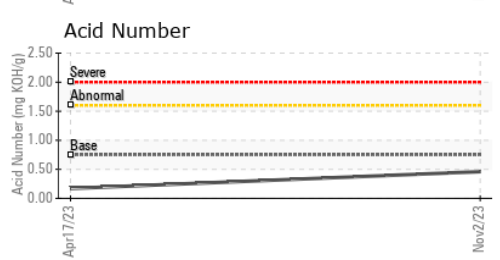
GRAPHS

All component wear rates are normal.

There is no indication of any contamination in the oil.

The AN level is acceptable for this fluid. The condition of the oil is suitable for further service.

Resample at the next service interval to monitor.
