OIL ANALYSIS REPORT

Area
APG Oil Analysis
 Machine Id
2 Air Compressor (S/N U3Z-C-3960)
 Component
Gearbox
 Fluid
SHELL TURBO T ISO 46 (70 GAL)

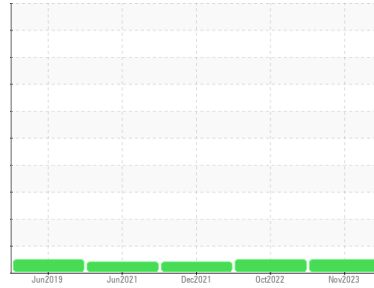
Sample Rating Trend

NORMAL

Resample at the next service interval to monitor.

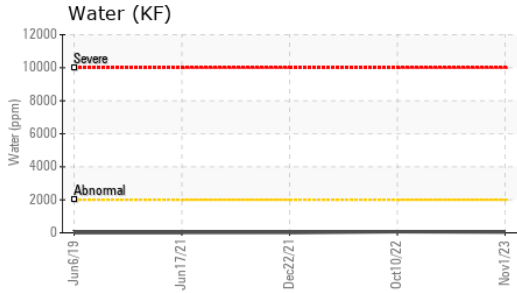
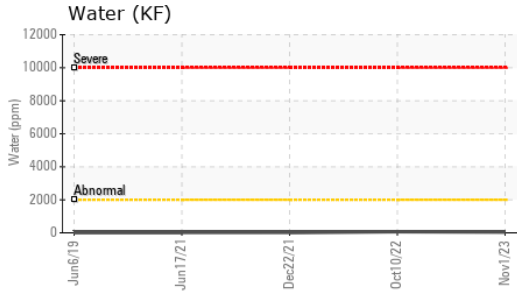
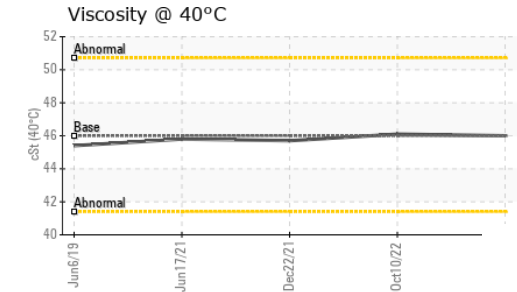
All component wear rates are normal.

There is no indication of any contamination in the oil.

The AN level is acceptable for this fluid. The condition of the oil is suitable for further service.
