# OIL ANALYSIS REPORT

Area  
**RIG 816**  
 Machine Id  
**R816-MP-02**  
 Component  
**Gearbox**  
 Fluid  
**NOT GIVEN (--- GAL)**

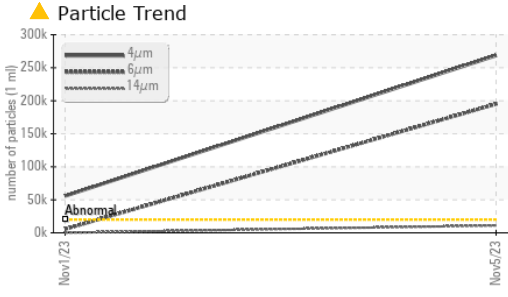
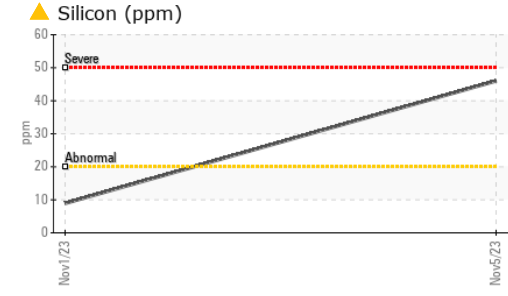
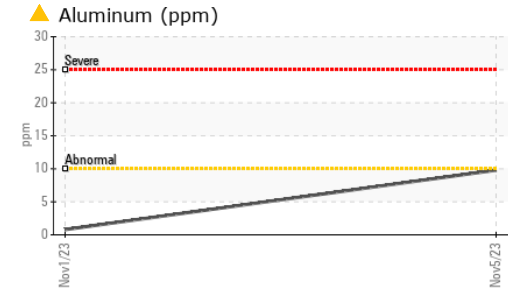
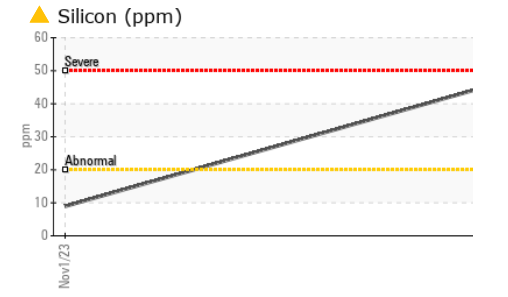
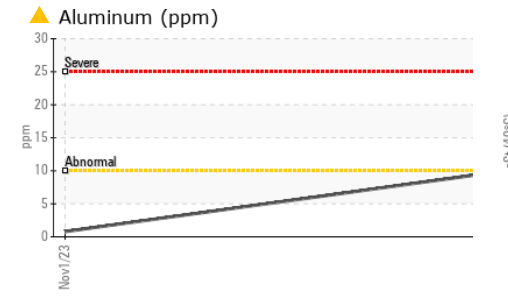
Gear wear is indicated.

There is a high amount of particulates present in the oil. Elemental levels of silicon (Si) and aluminum (Al) indicate alumina-silicate (coarse dirt) ingress.

WEAR METALS		method	limit/base	current	history1	history2
Iron	ppm	ASTM D5185m	>20	<b>▲ 256</b>	23	---
Chromium	ppm	ASTM D5185m	>10	<b>&lt;1</b>	0	---
Nickel	ppm	ASTM D5185m	>10	<b>0</b>	0	---
Titanium	ppm	ASTM D5185m		<b>3</b>	0	---
Silver	ppm	ASTM D5185m		<b>0</b>	0	---
Aluminum	ppm	ASTM D5185m	>10	<b>▲ 10</b>	<1	---
Lead	ppm	ASTM D5185m	>10	<b>0</b>	0	---
Copper	ppm	ASTM D5185m	>75	<b>36</b>	20	---
Tin	ppm	ASTM D5185m	>10	<b>0</b>	0	---
Vanadium	ppm	ASTM D5185m		<b>0</b>	0	---
Cadmium	ppm	ASTM D5185m		<b>0</b>	0	---

CONTAMINANTS		method	limit/base	current	history1	history2
Silicon	ppm	ASTM D5185m	>20	<b>▲ 46</b>	9	---
Sodium	ppm	ASTM D5185m		<b>83</b>	12	---
Potassium	ppm	ASTM D5185m	>20	<b>6</b>	0	---

FLUID CLEANLINESS		method	limit/base	current	history1	history2
Particles >4µm		ASTM D7647	>20000	<b>▲ 268480</b>	<b>▲ 55659</b>	---
Particles >6µm		ASTM D7647	>5000	<b>▲ 195185</b>	<b>▲ 5550</b>	---
Particles >14µm		ASTM D7647	>640	<b>▲ 11053</b>	104	---
Particles >21µm		ASTM D7647	>160	<b>▲ 559</b>	18	---
Particles >38µm		ASTM D7647	>40	<b>1</b>	0	---
Particles >71µm		ASTM D7647	>10	<b>0</b>	0	---
Oil Cleanliness		ISO 4406 (c)	>21/19/16	<b>▲ 25/25/21</b>	<b>▲ 23/20/14</b>	---

We advise that you check all areas where dirt can enter the system. We recommend you service the filters on this component if applicable. We recommend an early resample to monitor this condition.
