OIL ANALYSIS REPORT

Machine Id
CH150A-23120-01-1 - SMI217A WATER DECK (S/N 0100339)

Component
Main Winch

Fluid
CHEVRON MEROPA 220 (--- QTS)

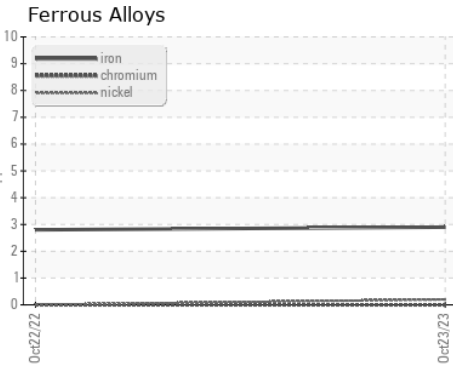
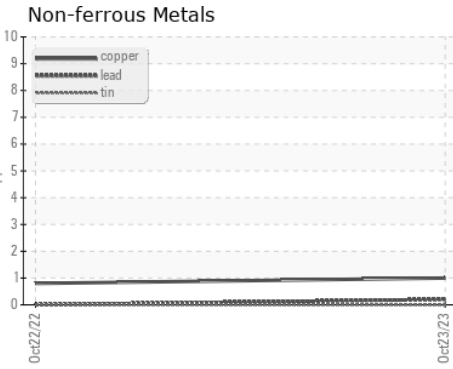
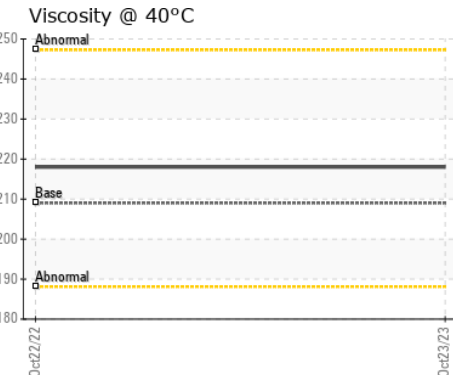
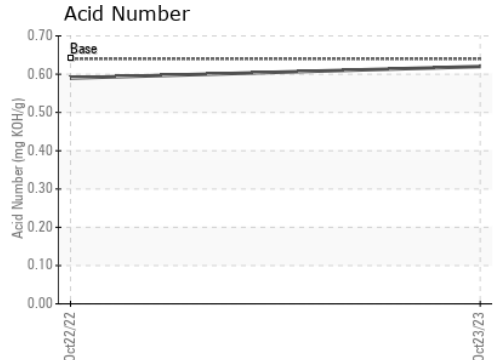
GRAPHS

All component wear rates are normal.

There is no indication of any contamination in the oil.

The AN level is acceptable for this fluid. The condition of the oil is suitable for further service.

Resample at the next service interval to monitor.
