OIL ANALYSIS REPORT

Machine Id
KAESER 4905210

Component
Compressor
Fluid
KAESER SIGMA (OEM) M-460 (--- GAL)

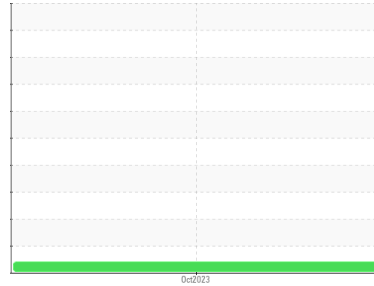
Sample Rating Trend

VIS DEBRIS

Sample Status				ABNORMAL	---	---
Debris	scalar	*Visual	NONE	▲ MODER	---	---

No corrective action is recommended at this time. The filter change at the time of sampling has been noted. Resample at the next service interval to monitor. We were unable to perform a particle count due to a high concentration of particles present in this sample.

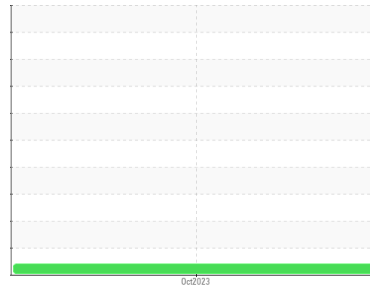
Sample Rating Trend

VIS DEBRIS

Moderate concentration of visible dirt/debris present in the oil.

No corrective action is recommended at this time. The filter change at the time of sampling has been noted. Resample at the next service interval to monitor. We were unable to perform a particle count due to a high concentration of particles present in this sample.
