Machine Id
9048132 (S/N NOT GIVEN)

Component
Compressor

Fluid
KAESER SIGMA (OEM) S-460 (--- QTS)

OIL ANALYSIS REPORT

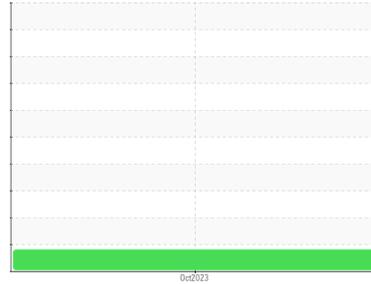
Sample Rating Trend

Sample Status			ATTENTION	---	---
Particles >6µm	ASTM D7647	>1300	▲ 1852	---	---
Oil Cleanliness	ISO 4406 (c)	>--/17/13	▲ 21/18/12	---	---

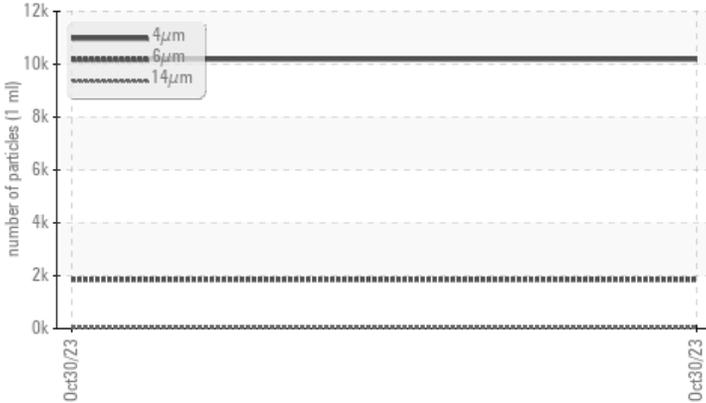
▲ Particle Trend

There is a moderate amount of silt (particulates < 14 microns in size) present in the oil.

No corrective action is recommended at this time. The filter change at the time of sampling has been noted. Resample at the next service interval to monitor.

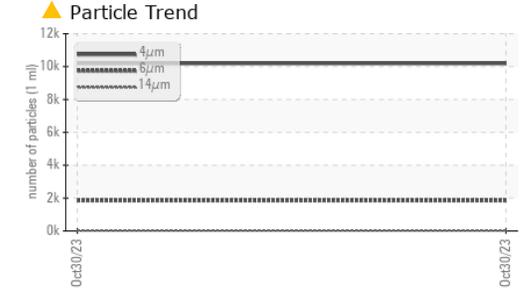
VISUAL	method	limit/base	current	history1	history2	
White Metal	scalar	*Visual	NONE	NONE	---	---
Yellow Metal	scalar	*Visual	NONE	NONE	---	---
Precipitate	scalar	*Visual	NONE	NONE	---	---
Silt	scalar	*Visual	NONE	NONE	---	---
Debris	scalar	*Visual	NONE	NONE	---	---
Sand/Dirt	scalar	*Visual	NONE	NONE	---	---
Appearance	scalar	*Visual	NORML	NORML	---	---
Odor	scalar	*Visual	NORML	NORML	---	---
Emulsified Water	scalar	*Visual	>0.05	NEG	---	---
Free Water	scalar	*Visual		NEG	---	---
