# PROBLEM SUMMARY

Machine Id  
**KAESER 8722338 (S/N 1549)**  
 Component  
**Compressor**  
 Fluid  
**KAESER SIGMA (OEM) S-460 (--- GAL)**

# OIL ANALYSIS REPORT

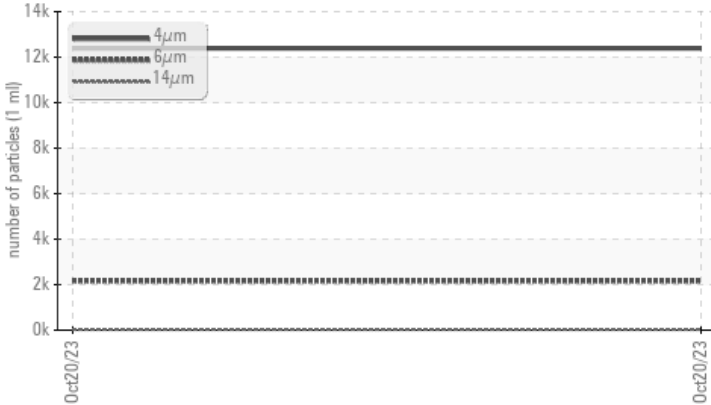
### ▲ Particle Trend

There is a moderate amount of silt (particulates < 14 microns in size) present in the oil.

FLUID CLEANLINESS		method	limit/base	current	history1	history2
Particles >4µm		ASTM D7647		<b>12383</b>	---	---
Particles >6µm		ASTM D7647	>1300	<b>▲ 2164</b>	---	---
Particles >14µm		ASTM D7647	>80	<b>29</b>	---	---
Particles >21µm		ASTM D7647	>20	<b>4</b>	---	---
Particles >38µm		ASTM D7647	>4	<b>0</b>	---	---
Particles >71µm		ASTM D7647	>3	<b>0</b>	---	---
Oil Cleanliness		ISO 4406 (c)	>17/13	<b>▲ 18/12</b>	---	---

## RECOMMENDATION

Oil and filter change at the time of sampling has been noted. Resample at the next service interval to monitor.

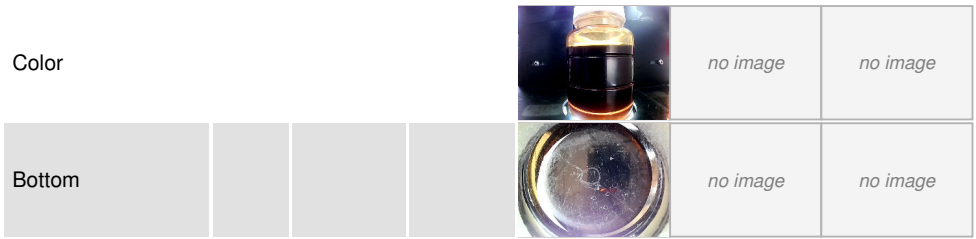
SAMPLE IMAGES	method	limit/base	current	history1	history2
---------------	--------	------------	---------	----------	----------

VISUAL	method	limit/base	current	history1	history2
White Metal	scalar	*Visual NONE	<b>NONE</b>	---	---
Yellow Metal	scalar	*Visual NONE	<b>NONE</b>	---	---
Precipitate	scalar	*Visual NONE	<b>NONE</b>	---	---
Silt	scalar	*Visual NONE	<b>NONE</b>	---	---
Debris	scalar	*Visual NONE	<b>NONE</b>	---	---
Sand/Dirt	scalar	*Visual NONE	<b>NONE</b>	---	---
Appearance	scalar	*Visual NORML	<b>NORML</b>	---	---
Odor	scalar	*Visual NORML	<b>NORML</b>	---	---
Emulsified Water	scalar	*Visual >0.05	<b>0.2%</b>	---	---
Free Water	scalar	*Visual	<b>NEG</b>	---	---
