OIL ANALYSIS REPORT

Machine Id
CATERPILLAR D10T 15105049 (S/N CATOD10TCRJG01495)
 Component
Left Final Drive
 Fluid
CHEVRON 50WT (--- GAL)

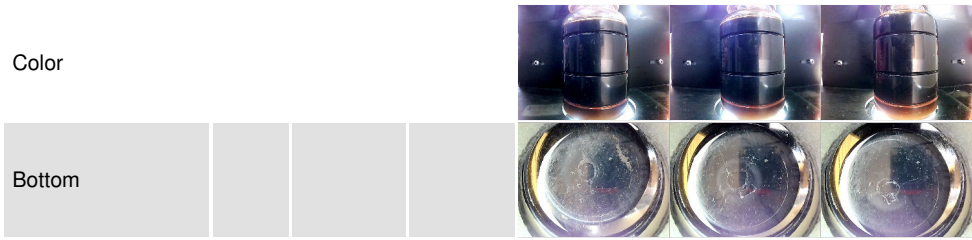
SAMPLE IMAGES		method	limit/base	current	history1	history2
---------------	--	--------	------------	---------	----------	----------

method	limit/base	current	history1	history2
White Metal	scalar	*Visual NONE	NONE	NONE	NONE
Yellow Metal	scalar	*Visual NONE	NONE	NONE	NONE
Precipitate	scalar	*Visual NONE	NONE	NONE	NONE
Silt	scalar	*Visual NONE	NONE	NONE	NONE
Debris	scalar	*Visual NONE	NONE	NONE	NONE
Sand/Dirt	scalar	*Visual NONE	NONE	NONE	NONE
Appearance	scalar	*Visual NORML	NORML	NORML	NORML
Odor	scalar	*Visual NORML	NORML	NORML	NORML
Emulsified Water	scalar	*Visual >0.2	NEG	NEG	NEG
Free Water	scalar	*Visual	NEG	NEG	NEG

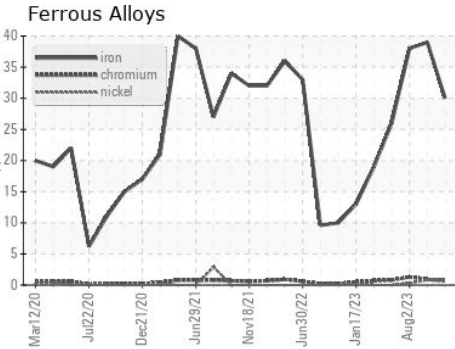
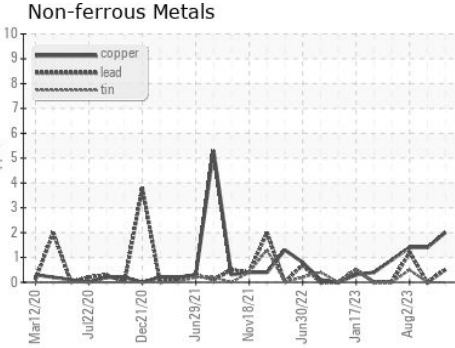
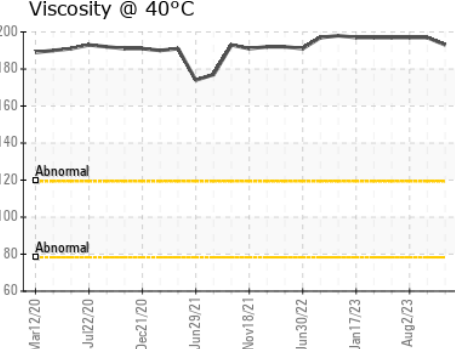
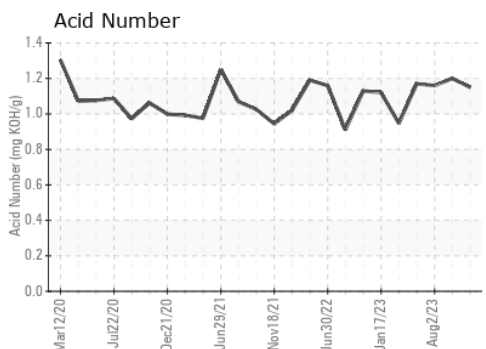
GRAPHS

All component wear rates are normal.

There is no indication of any contamination in the oil.

The AN level is acceptable for this fluid. The condition of the oil is suitable for further service.

Resample at the next service interval to monitor.
