FUEL REPORT

Area
GUAY SON
Machine Id
IBACO COZAR VII
Component
Front Diesel Fuel
Fluid
NOT GIVEN (--- GAL)

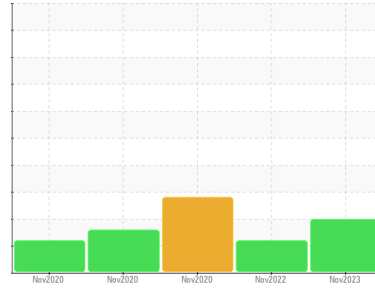
Sample Rating Trend

There is a high amount of particulates present in the fuel. The water content is negligible.

We advise that you filter this fluid before use.

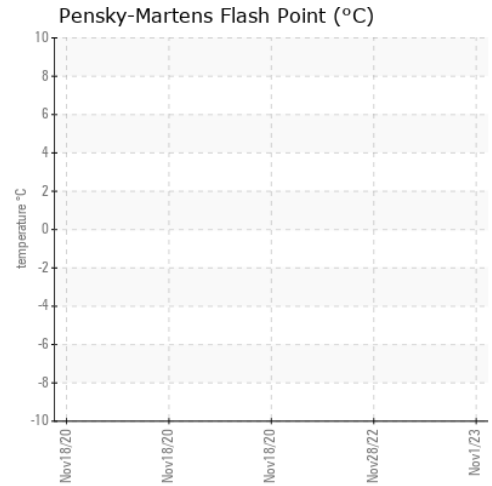
GRAPHS

FLUID CLEANLINESS		method	limit/base	current	history1	history2
Particles >4µm		ASTM D7647	>2500	▲ 34107	---	1040
Particles >6µm		ASTM D7647	>640	▲ 9578	---	566
Particles >14µm		ASTM D7647	>80	▲ 619	---	▲ 96
Particles >21µm		ASTM D7647	>20	▲ 134	---	▲ 32
Particles >38µm		ASTM D7647	>4	2	---	▲ 5
Particles >71µm		ASTM D7647	>3	0	---	0
Oil Cleanliness		ISO 4406 (c)	>18/16/13	▲ 22/20/16	---	▲ 16/14
